MSP430FG4617 Device Erratasheet

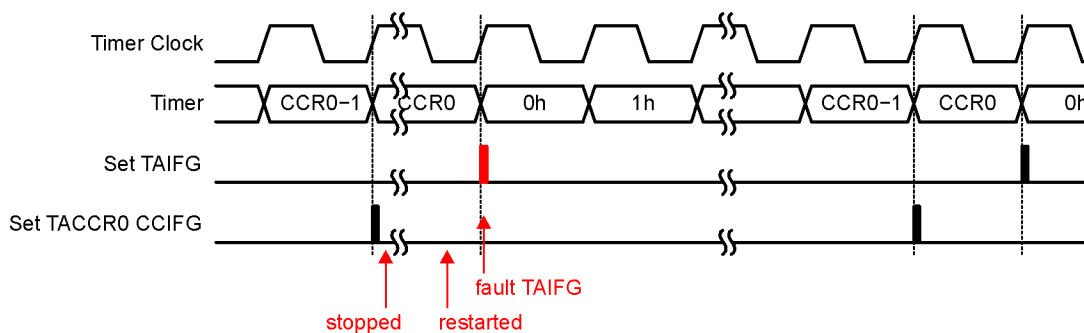
TA21

TAIFG Flag is erroneously set after Timer A restarts in Up Mode

In Up Mode, the TAIFG flag should only be set when the timer counts from TACCR0 to zero. However, if the Timer A is stopped at TAR = TACCR0, then cleared (TAR=0) by setting the TACLK bit, and finally restarted in Up Mode, the next rising edge of the TACLK will erroneously set the TAIFG flag.

None.
