Stellaris® LM3S Sandstorm-, Fury-, and DustDevil-Class Microcontrollers Errata

Silicon Errata

Literature Number: SPMZ860

June 2014

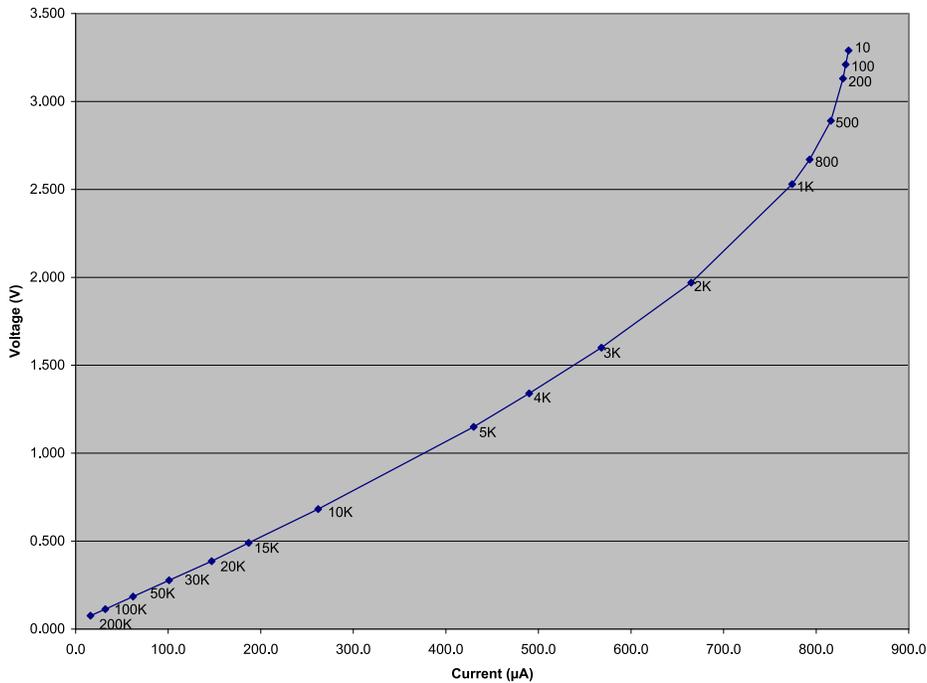
Figure 2. Voltage versus Current for Various External Pull-up Resistors on PB0

The characteristic of the pull-down for PB0 is shown in [Figure 2](#). The data labels for each data point show the external pull-up resistance in Ohms.

Workaround(s): When either of these pins is configured as an input, the external circuit must provide enough drive strength to over-drive the internal pull-down and achieve the necessary V_{IH} voltage level. If an external pull-up resistor is used, it must have a low value such as ~1 KΩ or less for PB0 and ~50 KΩ or less for PB1.

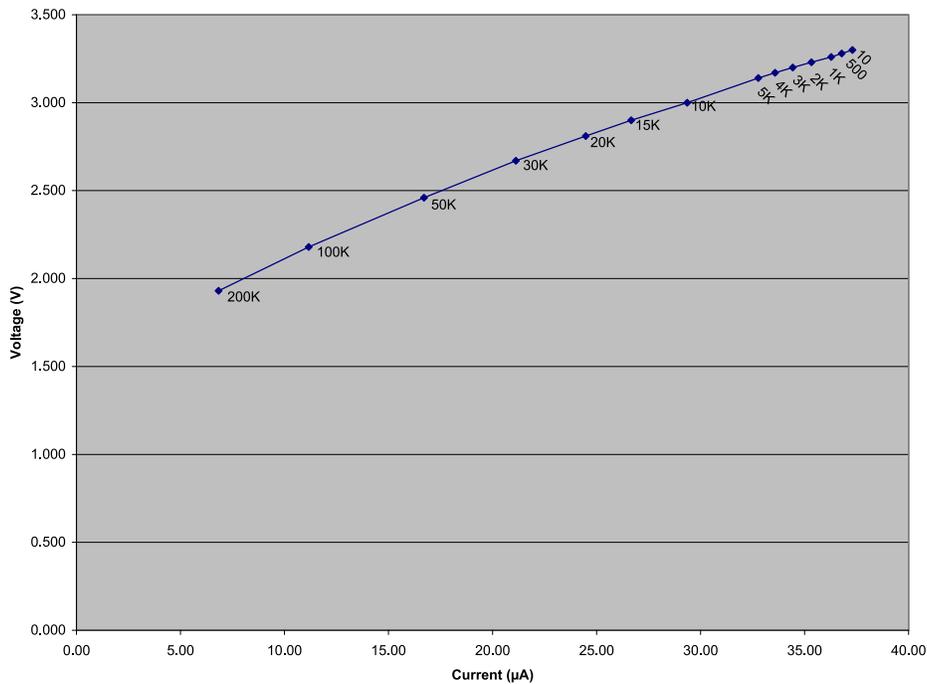
Figure 3. Voltage versus Current for Various External Pull-up Resistors on PB1

The characteristic of the pull-down for PB1 is shown in [Figure 3](#). The data labels for each data point show the equivalent resistance in Ohms.

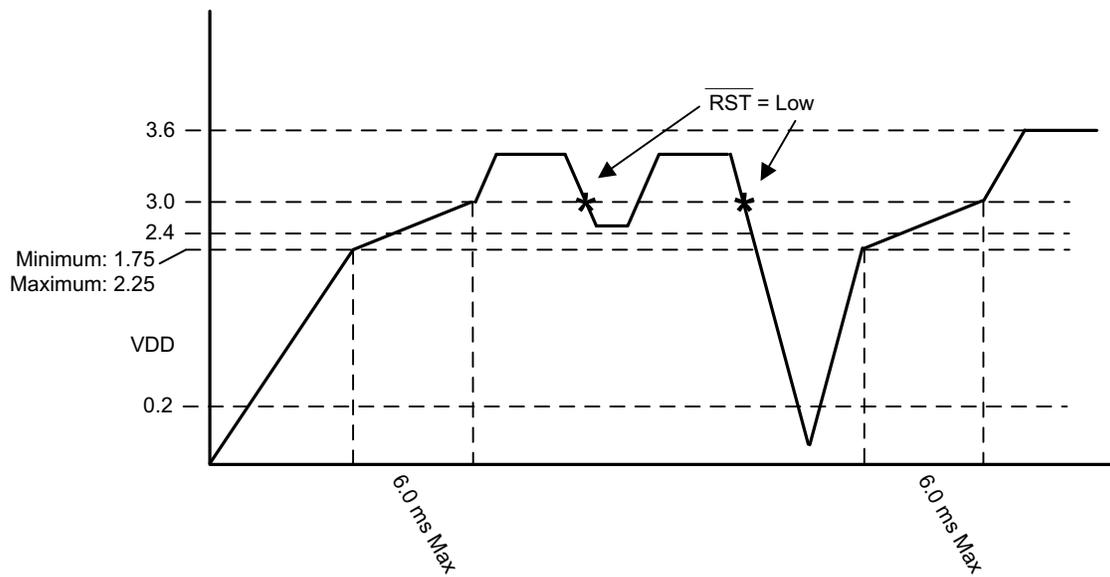
Figure 5. VDD Waveform Signature Limits

The LDO, which supplies power to the microcontroller's internal logic, may fail to initialize properly during the power-up sequence. If the LDO does not initialize correctly, the LDO does not supply enough power to the microcontroller's internal logic, user code is not executed, and the GPIOs are in an indeterminate state. This failure can potentially occur when powering on the device from 0 V, though it most commonly occurs when VDD powers on from a voltage just above 200 mV.

The internal Brown-Out Reset circuit is designed to guard against improper operation of logic when VDD is below the minimum operating voltage. However, the brown-out supervisor has a threshold as low as 2.68 V, which is less than the minimum operating voltage on VDD, and it can take several microseconds to respond to a brown-out event. This delay creates a gap in the protection of the device. BOR gaps can be encountered after power up, during steady state operation, if the VDD rail has glitches, and also during power-down.

Due to the erratum, the following adjustments to the parameters in [Table 4](#) and [Table 5](#) should be observed in system design:
