TMS320C6748 Fixed- and Floating-Point DSP Silicon Revisions 2.3, 2.1, 2.0, 1.1 and 1.0

Silicon Errata

Literature Number: SPRZ303H
June 2009–Revised March 2014

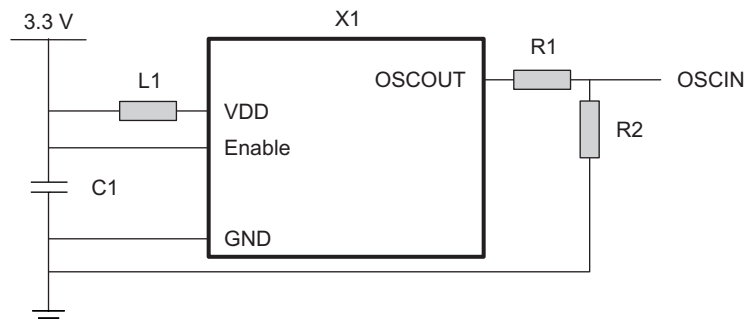
Figure 2. External 3.3V Clock Source

On all silicon revisions, certain design elements make this device susceptible to radiated noise during an ESD strike, as described in the standard IEC 61000-4-2. Exposure to the electrical noise caused by the ESD can cause soft device failures due to noise coupling on the system clock (OSCIN). ESD events within the IEC spec range do not cause permanent device damage and full functionality is recoverable with a device reset. The sensitivity to this noise issue is primarily due to the 1.2V oscillator/clock input implemented on this device. The low voltage range, coupled with slow rise and fall times, provides a lower noise margin than other TI devices with higher voltage internal oscillators (for example, 1.8V or 3.3V oscillators).

If ESD robustness is a concern, it is strongly recommended to avoid using the internal oscillator as a clock source. An external 3.3V clock source with a resistor voltage divider as in [Figure 2](#) can be used to externally generate the required 1.2V input clock. By using an external clock input with fast rise/fall times (less than 5 ns), the noise margin improves significantly, increasing ESD noise resistance.

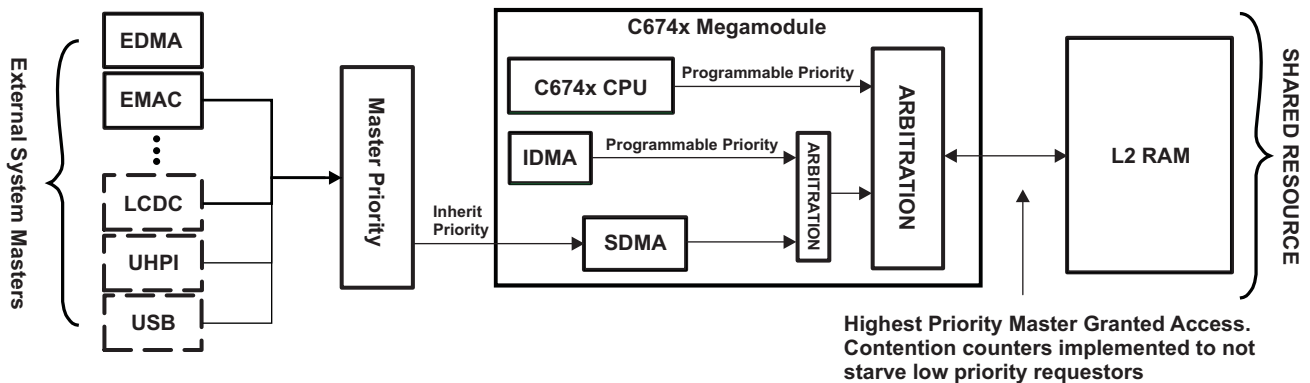
Figure 3. Priority Arbitration Scheme for L2 RAM

Ideally, the BWM arbitration will grant equal L2 bandwidth between equal priority DMA and CPU requests. Instead, when equal priority DMA and CPU requests arrive at the BWM, bandwidth is always granted in favor of the CPU over DMA. In the case of successive CPU requests, it is possible for the CPU to block all DMA requests until CPU traffic subsides. Additionally, some command logic in the BWM uses priority level 7, which can also result in SDMA stalls when the CPU is also programmed to priority level 7. [Figure 3](#) shows a high level diagram of the arbitration scheme used for L2 RAM requests.

Workaround(s) Configure DMA and CPU requests to different priority levels. There is no penalty for setting the IDMA and SDMA priorities equal to each other.

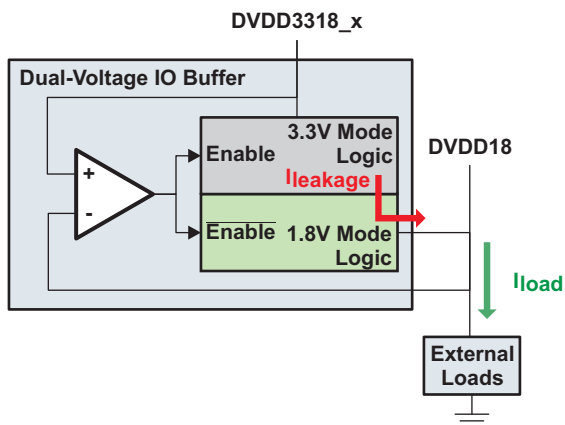
Figure 8. Error State of the IO buffer during Zone G

As DVDD3318_x exceeds DVDD18+V_T, some of the circuitry across the boundary of the two voltage domains will turn on and causes a leakage current (in red) to flow between the two voltage domains. This current pulls up the DVDD18 supply unless the power source providing that supply can oppose it or unless the load current is strong enough to counteract it.

If DVDD18 continues to rise as DVDD3318_x ramps, the comparator never sees enough difference between the two supplies to switch to 3.3V mode.
