AM1705 ARM Microprocessor Silicon Revisions 3.0, 2.1, and 2.0

Silicon Errata

Literature Number: SPRZ311E
March 2010–Revised June 2014

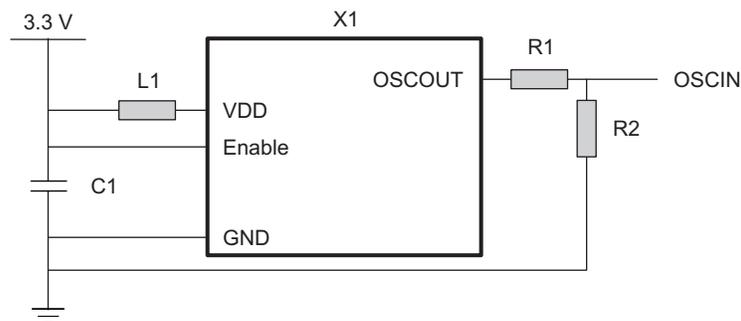
Figure 1. External 3.3V Clock Source

On all silicon revisions, certain design elements make this device susceptible to radiated noise during an ESD strike, as described in the standard IEC 61000-4-2. Exposure to the electrical noise caused by the ESD can cause soft device failures due to noise coupling on the system clock (OSCIN). ESD events within the IEC spec range do not cause permanent device damage and full functionality is recoverable with a device reset. The sensitivity to this noise issue is primarily due to the 1.2V oscillator/clock input implemented on this device. The low voltage range, coupled with slow rise and fall times, provides a lower noise margin than other TI devices with higher voltage internal oscillators (for example, 1.8V or 3.3V oscillators).

If ESD robustness is a concern, it is strongly recommended to avoid using the internal oscillator as a clock source. An external 3.3V clock source with a resistor voltage divider as in [Figure 1](#) can be used to externally generate the required 1.2V input clock. By using an external clock input with fast rise/fall times (less than 5 ns), the noise margin improves significantly, increasing ESD noise resistance.
