# ***DRA75x, DRA74x SoC for Automotive Infotainment Silicon Revision 2.0, 1.1***

This document describes the known exceptions to the functional specifications for the device.

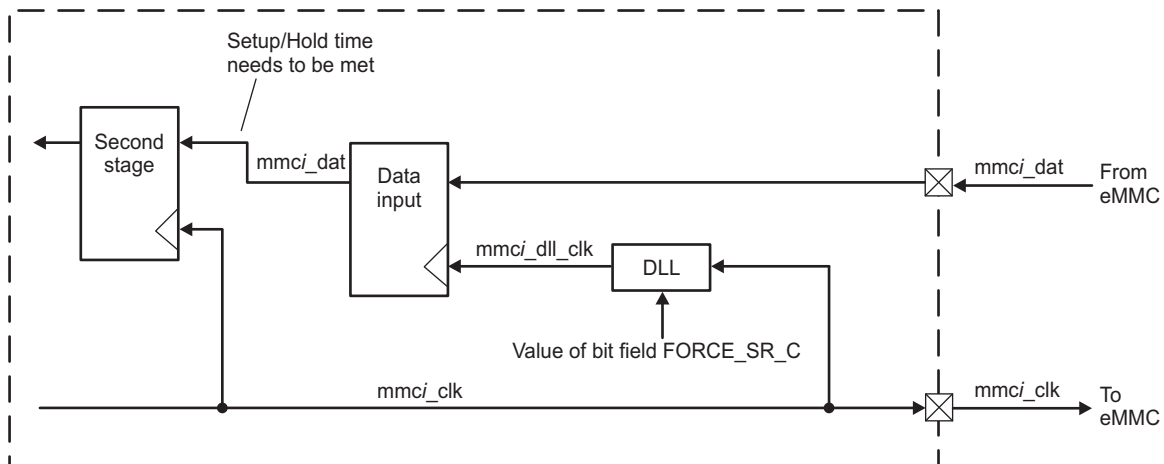
**Figure 2. Simplified SoC 192-MHz Mode DLL Block Diagram**

**DESCRIPTION** Internal to the MMC module, a second stage latch is used to recapture data captured by DLL delayed CLK, MMC\_DLL\_CLK. The second stage latch captures with the original transmitting clock, MMC\_CLK.

MMC\_DLL\_CLK and MMC\_CLK both run at the same clock frequency. This results in a narrow range of tuning ratio elements, where the delayed MMC\_DLL\_CLK comes in phase with MMC\_CLK. If the clocks are in phase, the data captured by the first clock violates the setup and hold time requirements needed for the second stage latch, resulting in incorrectly read data. This is known as tuning re-timing errors.

A DLL tuning algorithm has been implemented that can avoid the tuning re-timing errors. More details on this can be found in App Note [SPRACA9](#). The following notes summarize the updated algorithm:
