# **TMS320F2837xS Delfino™ MCUs Silicon Revisions C, B**

This document describes the silicon updates to the functional specifications for the TMS320F2837xS microcontrollers (MCUs).

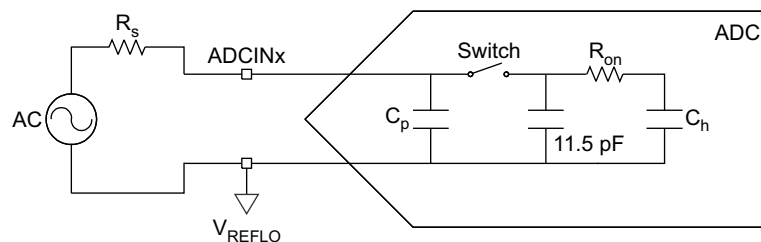
**Figure 3. Single-Ended Input Model**

<b>Advisory</b>	<b><i>ADC: 12-Bit Input Capacitance When Switching Channel Groups</i></b>
<b>Revision(s) Affected</b>	B
<b>Details</b>	The ADC input model should be used to select the sample-and-hold (S+H) duration for each ADC input. For the revisions affected, if the currently converting channel is an even-numbered channel and the previously converted channel was an odd-numbered channel (or vice versa), then the 12-bit input model will not accurately predict ADC input performance. Under these conditions, an additional capacitance should be added to the model. This capacitance has a value of 11.5 pF and should be placed between the S+H switch and $R_{on}$ as shown in <a href="#">Figure 3</a> .

<b>Workaround(s)</b>	For the revisions affected, when subsequent conversions switch between channel groups, the S+H duration should be chosen to account for the additional capacitance.
----------------------	---
