**CC1021 Errata Note 001, rev. 1.0**

March 1, 2005

**CC1021 Errata Note 002, rev. 1.0**

March 14, 2005

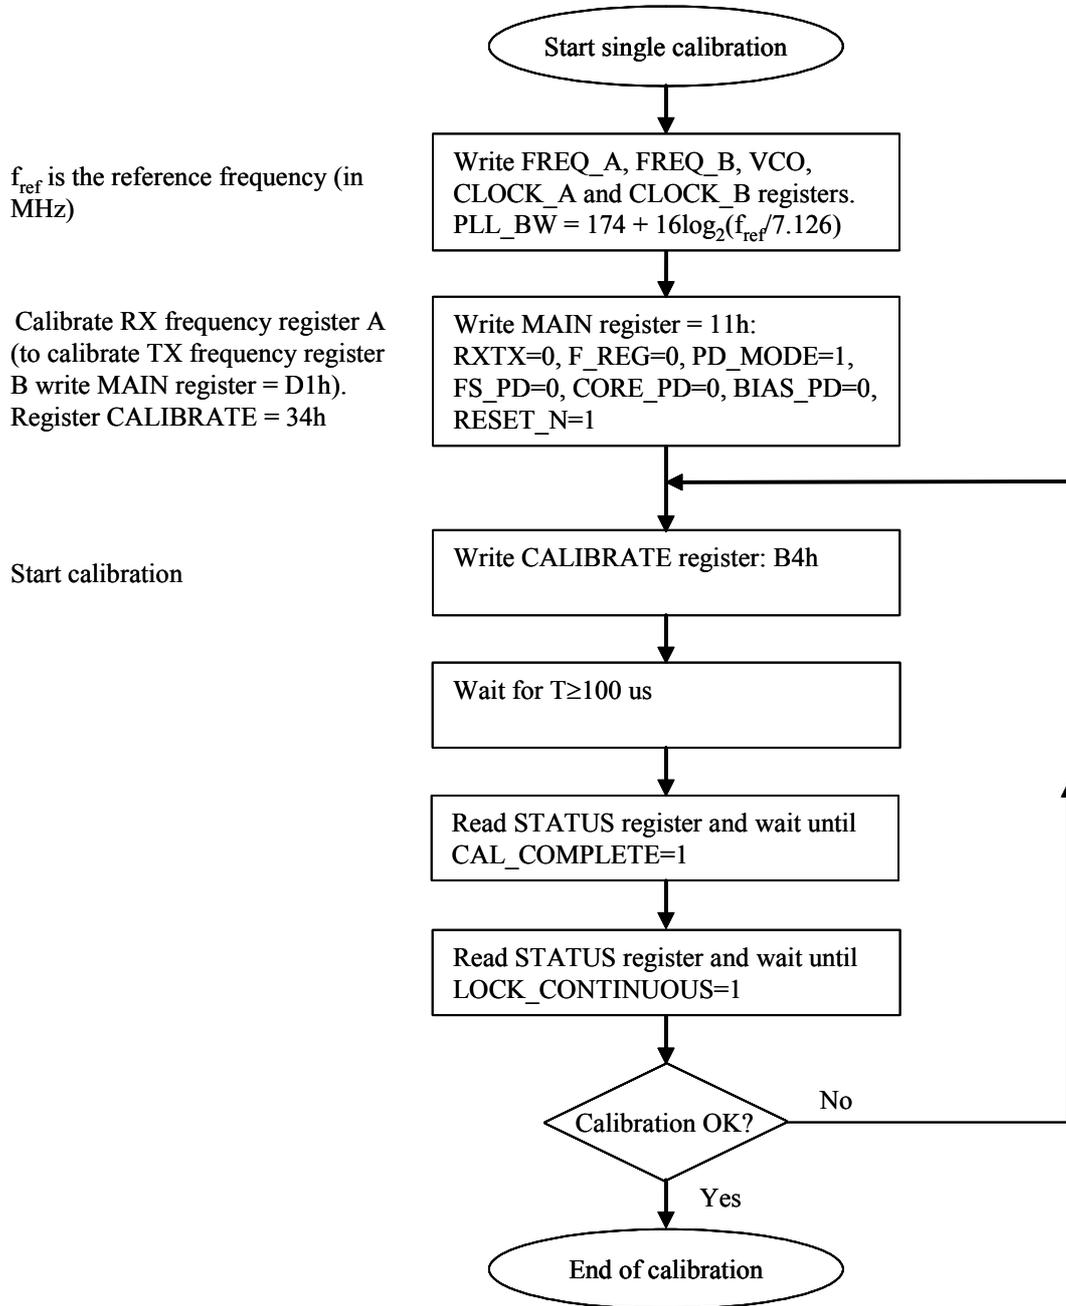
Figure 1: Recommended PLL calibration procedure

When performing PLL calibration it has been verified that waiting at least 100  $\mu$ s after initiating the calibration is necessary to avoid an unreliable PLL calibration result. Still, there exists a small, but finite probability that the CC1021 PLL will not LOCK. Checking LOCK and recalibrating if LOCK is not achieved is therefore necessary.

In less than 10 ppm of all PLL calibrations performed it was observed that CC1021 did not achieve LOCK even when introducing a 100  $\mu$ s wait period before polling of [STATUS.CAL\_COMPLETE] was initiated. The reason for no LOCK still occurring, even when calibrating the PLL with this small wait period, is due to the PLL calibration procedure making an erroneous frequency measurement causing the PLL calibration algorithm to choose a wrong capacitor array setting producing a no LOCK situation. For this reason it is important to control that the PLL calibration achieves LOCK and recalibrate if it does not.

Calibration starts when CALIBRATE.CAL\_START is set to 1 as shown in figure 1. The PLL is then set to open loop and the internal VCO control voltage set to a value given by CALIBRATE.CAL\_ITERATE[2:0] = 4<sub>n</sub>. Based on this value a capacitor array is selected and when the calibration is completed the PLL loop is closed.

For those users who have not already implemented a recalibration procedure in software it is strongly recommended to avoid polling [STATUS.CAL\_COMPLETE] until 100  $\mu$ s has elapsed following calibration start, then monitor LOCK after calibration complete and, if LOCK is not achieved, recalibrate until LOCK is successfully achieved. The recommended calibration procedure, including recalibration, is provided in figure 1.
