ERRATA NOTES

CC110L

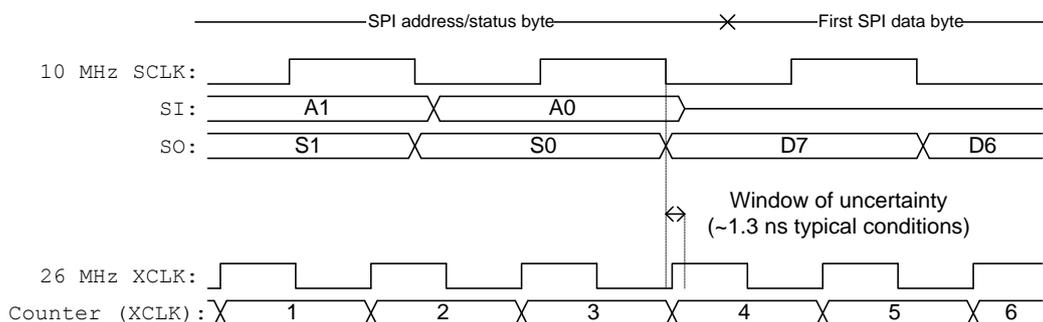
Figure 1: Window of Uncertainty (drawing not to scale)

Due to this synchronization issue, if the register being read changes value (synchronously with XCLK) during a certain period of time after this falling edge of SCLK then some of the bits in the read value will come from the previous value and some from the next value. This so-called window of uncertainty is about 1.3 ns for typical conditions and increases to about 2.0 ns for worst-case conditions (1.8 V VDD, 85 °C).

Figure 1 shows a timing diagram of an SPI read that fails when reading a fictitious counter being updated internally each XCLK. Since the counter update from value 3 (011b) to 4 (100b) within the window of uncertainty, the read value could be any one of 0-7 (000b, 001b, 010b, 011b, 100b, 101b, 110b, 111b) depending on exactly when the positive edge of XCLK falls within the window of uncertainty.

If it is important to **ensure** that read values are not corrupted, reading of one of the affected registers should be done repeatedly until the same value is read twice in succession. If the rate at which the register is read is specified to be at least twice as fast as the expected register update rate, then an upper bound on the number of required reads is four and the average number of reads slightly more than two.
