MSP430CG4619 Device Erratasheet

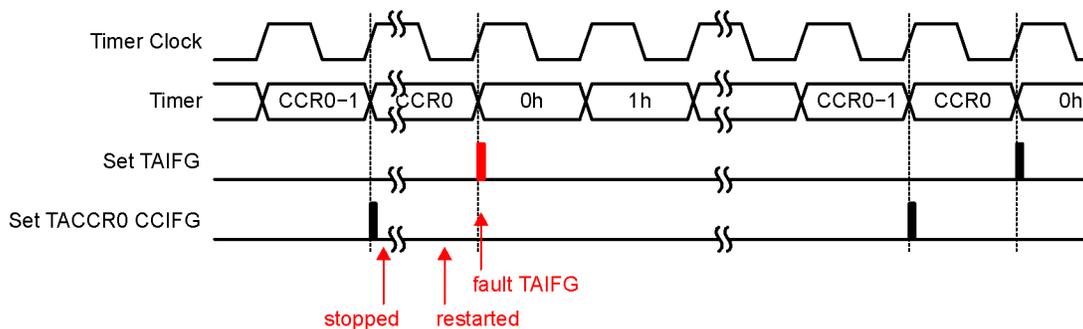
TA21 *TIMER_A Module*

Function TAIFG Flag is erroneously set after Timer A restarts in Up Mode

Description In Up Mode, the TAIFG flag should only be set when the timer counts from TACCR0 to zero. However, if the Timer A is stopped at TAR = TACCR0, then cleared (TAR=0) by setting the TACL R bit, and finally restarted in Up Mode, the next rising edge of the TACL K will erroneously set the TAIFG flag.

Workaround None.

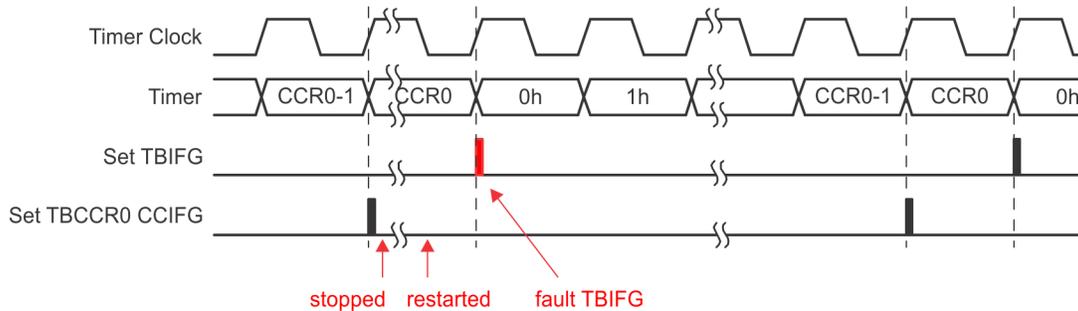
TB24 *TIMER_B Module*

Function TBIFG Flag is erroneously set after Timer B restarts in Up Mode

Description In Up Mode, the TBIFG flag should only be set when the timer resets from TBCCR0 to zero. However, if the Timer B is stopped at TBR = TBCCR0, then cleared (TBR=0) by setting the TBCLR bit, and finally restarted in Up Mode, the next rising edge of the TBCLK will erroneously set the TBIFG flag.

Workaround None.
