Errata
MSP430G2955 Microcontroller

ABSTRACT

This document describes the known exceptions to the functional specifications (advisories).

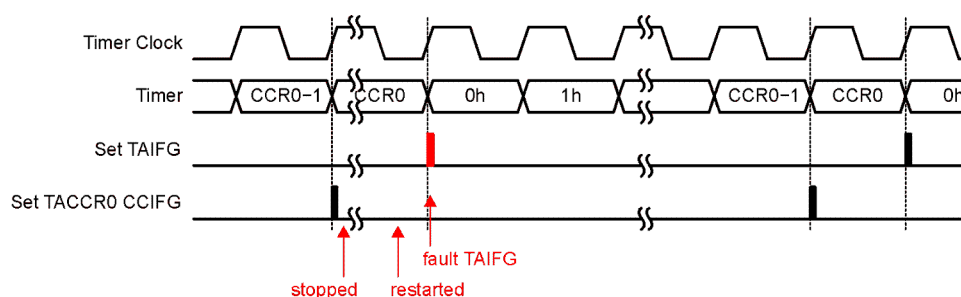
Function TAIFG Flag is erroneously set after Timer A restarts in Up Mode

Description In Up Mode, the TAIFG flag should only be set when the timer counts from TACCR0 to zero. However, if the Timer A is stopped at TAR = TACCR0, then cleared (TAR=0) by setting the TACLR bit, and finally restarted in Up Mode, the next rising edge of the TACLK will erroneously set the TAIFG flag.

Workaround None.
