Stellaris® LM3S9B92 RevB1 Errata

This document contains errata as of October 2013 for the Stellaris LM3S9B92 microcontroller. Additional errata added after October 2013 that apply to revision B1 can be found in the *Stellaris® LM3S Tempest- and Firestorm-Class Microcontrollers Errata (SPMZ861)*. Read both documents for the complete list of errata for your device.

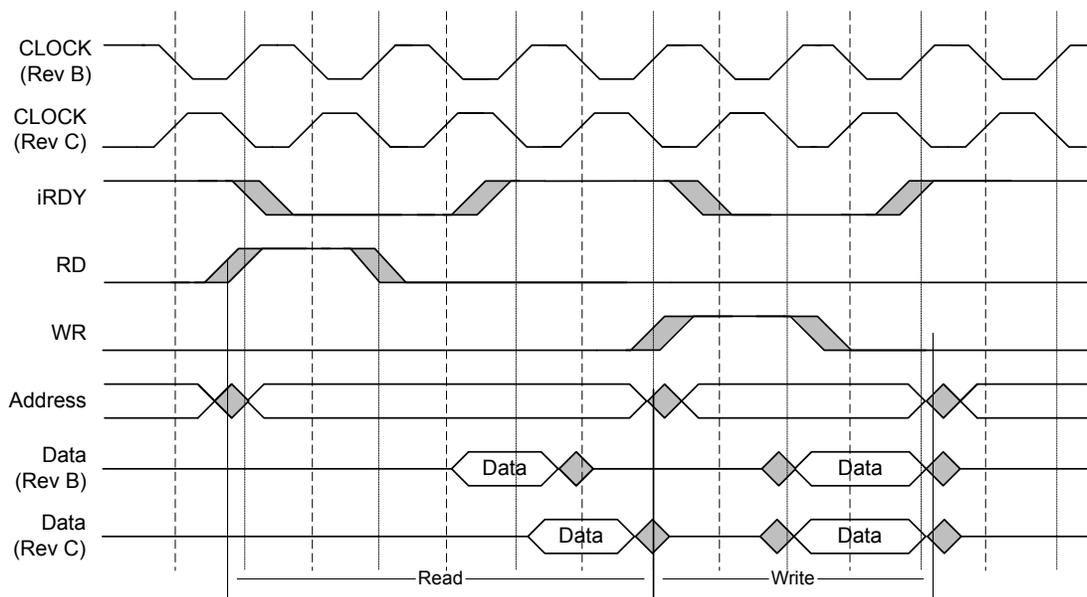
Figure 5. Timing Differences Between Rev B and Rev C Devices

The clock signal that is output on the EPIOS31 signal in General-Purpose mode is inverted. Figure Figure 5 on page 24 shows the timing differences between Rev B parts and Rev C parts.

Use the opposite edge for timing when designing with this interface. During read cycles, ensure that the data meets set up and hold times for the appropriate edge as shown in the diagram above.

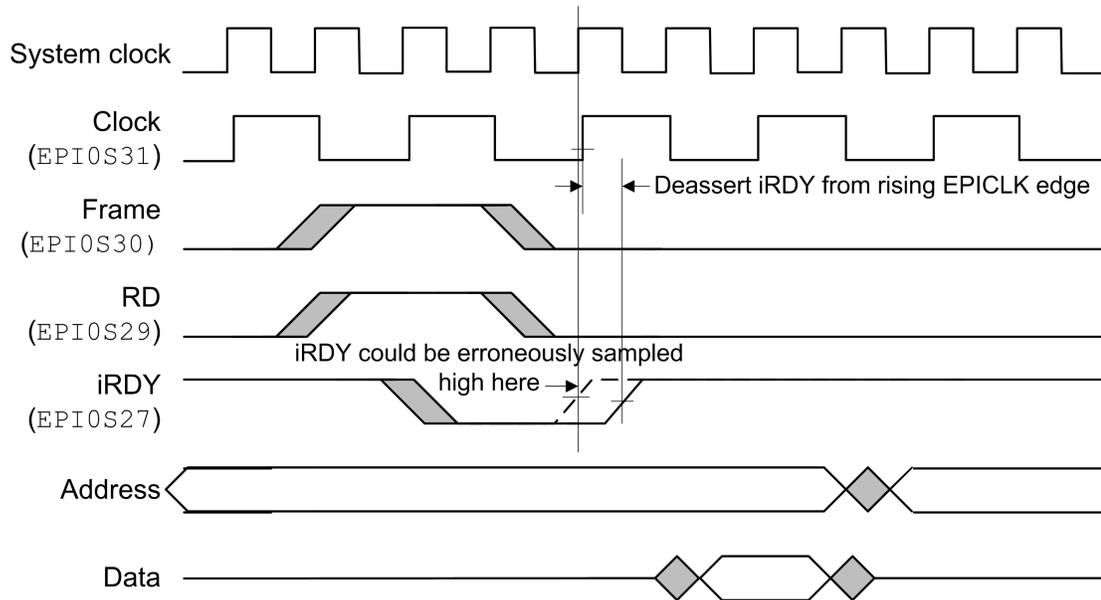
Figure 6. iRDY Timing

For example, if the system clock frequency is configured for 80 MHz (12.5 ns period) and the EPI clock frequency is configured for 40 MHz (25 ns period), there is a 2.5 ns window $((25 \text{ ns} - 12.5 \text{ ns}) - 10 \text{ ns})$, where 10 ns is the iRDY assertion or deassertion set up time (TRDYSU) where the iRDY signal may be asserted. Figure 6 on page 28 shows where iRDY is actually sampled when trying to stall the data phase. iRDY should be deasserted after the next falling edge of EPICLK. iRDY could be erroneously sampled high if it is deasserted at the dotted line.

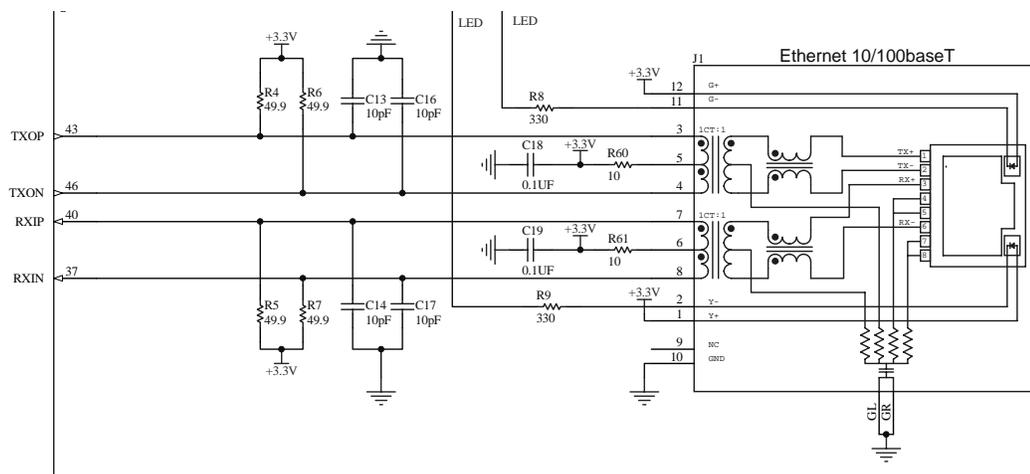
Figure 7. Recommended Center-Tap Connections

The microcontroller experiences some packet loss with Ethernet cables longer than 50 meters in normal operating conditions.

1. Add 10 Ω resistor to the center-tap of the transformer as shown in the figure. These resistors should be replaced by a direct connection for silicon that has this item fixed.
2. Continue using the recommended circuit, but limit cable lengths to 50 meters.

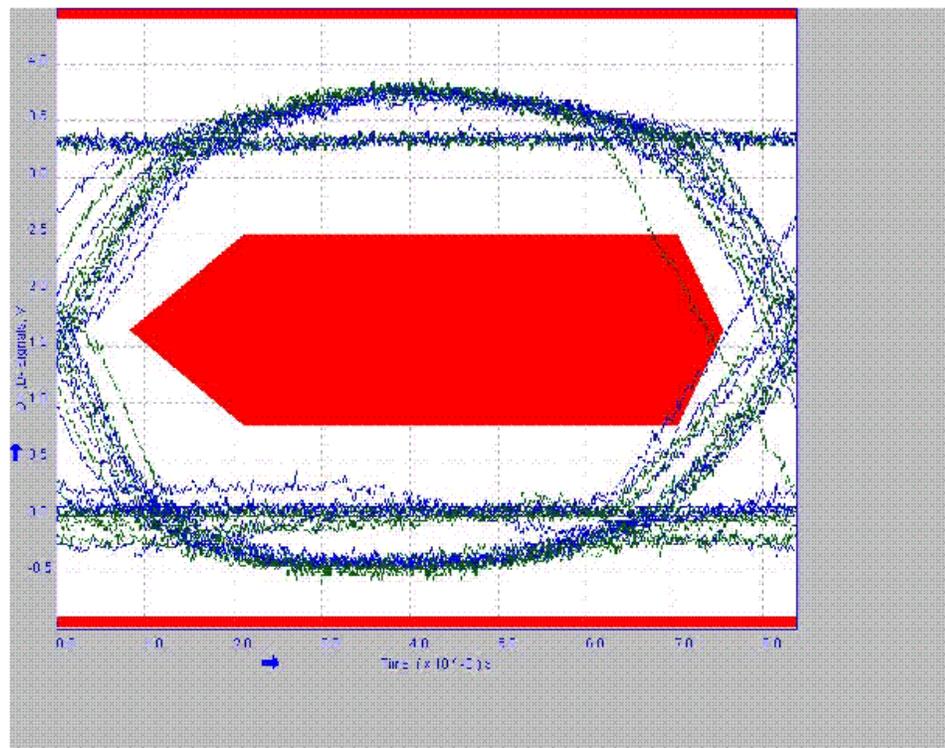
Figure 8. Example of USB Certification Failure

If the EPI module is operating, the USB interface may fail USB certification. Failures have been seen for the eye diagram and jitter (see Figure 8 on page 47). Because of these issues, there is a potential for data corruption on the USB interface when using the USB and EPI at the same time. The risk of data corruption is small, but is dependent on the system design.

- Signal eye:
Eye Diagram Test fails

- EOP width: 169.0995ns
EOP width passes
- Receivers: reliable operation on tier Tier 6
Receivers pass
- Measured Signalling Rate: 11.92707Mbps
signal rate conditionally passes
- Crossover voltage range: 1.546667 V to 1.680000 V
Mean crossover = 1.615889 V
First crossover at 1.660000 V(11 other differential crossovers checked)
crossover voltages pass
- Consecutive jitter range: -165.1885ns to 1.811468ns, RMS jitter 52.27256ns
Paired JK jitter range: 752.3810ps to 2.871429ns, RMS jitter 1.821542ns
Paired KJ jitter range: 1.185714ns to 2.168571ns, RMS jitter 1.695397ns
jitter fails

USB certification can be attained if an application does not require the USB and the EPI to be operating simultaneously. Customers who do not intend to pursue USB certification should determine if their application can handle the resulting small amount of error.

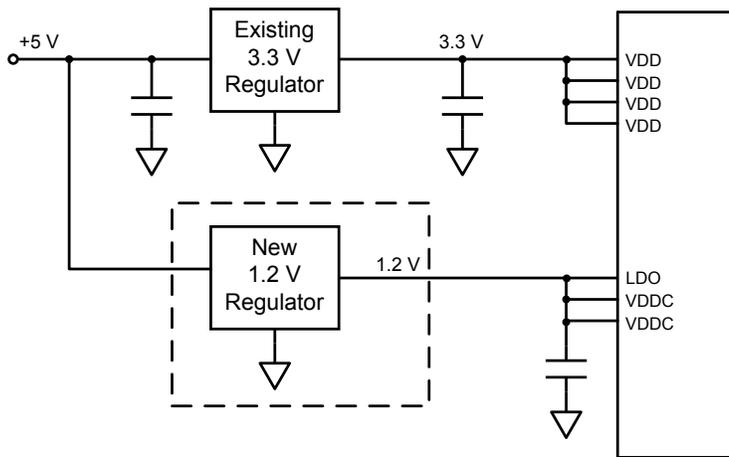
Figure 13. Configuration of External Regulator

Incorrect power sequencing during power up can disrupt operation and potentially cause device failure.

V_{DDC} must be applied approximately 50 μs before V_{DD} . Normally V_{DDC} is controlled by the part's internal LDO voltage regulator. The workaround requires the addition of an external regulator (see Figure 13) to ensure that V_{DDC} sequencing requirements are met (see Figure 14). A recommended regulator is the TI TPS73101DBVR.

This fix mitigates the on-chip power issue, but does not solve it completely. During development, the Flash memory should also be reprogrammed (using LMFlash or another programming tool) at least once a week.
