TMS320TCI6618

Communications Infrastructure KeyStone SoC

Silicon Revisions 1.0, 2.0

Silicon Errata

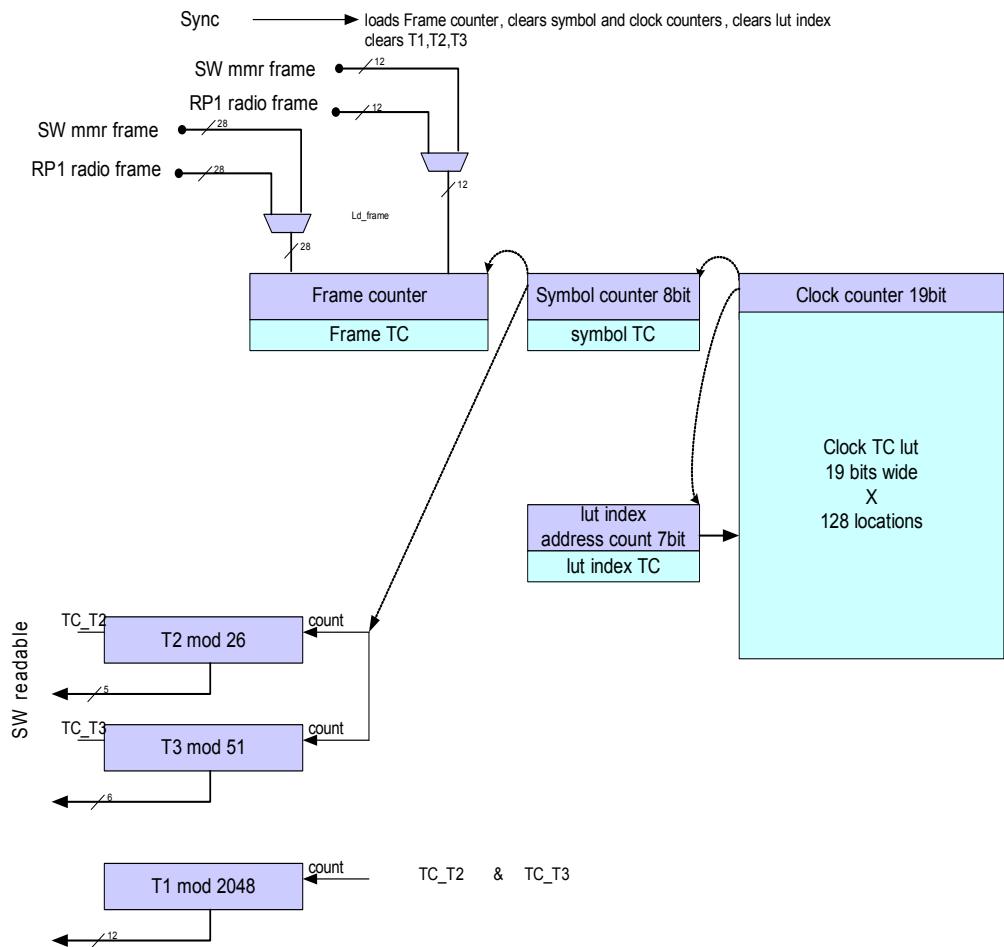
Figure 4 Radio Timer with GSM Time

However, one architecture problem was found while running the GSM system level test. The radio timer frame counter is programmed to count 60 ms, which is 13 GSM frame lengths. This configuration had to be done, because 60 ms is the first $n \times 10$ ms frame boundary which aligns to the OBSAI/CPRI PHY frame boundary (10 ms). In this case, the radio timer should have 104 as a symbol terminal count because there are a total of 104 GSM time slots within 60 ms. In this case, the radio timer should have 104 as a symbol terminal count because there are 104 GSM time slots within 60 ms. With a 104 symbol terminal count, there are not enough calculations to show the correct values on the T1, T2, and T3 counters.

Workaround: An additional AT event can be assigned to generate an event every GSM slot time. The ISR may check mod 8 count per visit and the T2 and T3 count array can be updated manually when the mod 8 count wraps around. TC_T1 count can be calculated by a bitwise AND operation between TC_T2 and TC_T3.

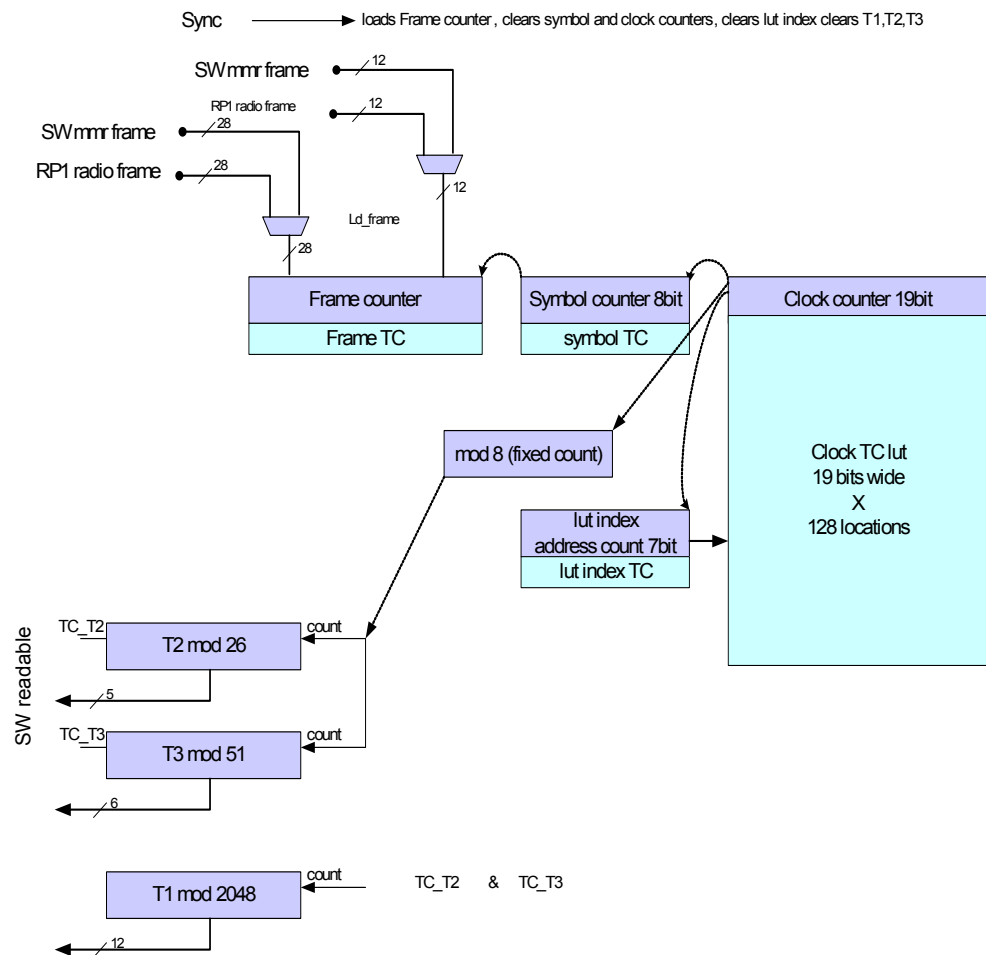
Figure 5 GSM T Counter Design Change

To fix this problem, it is necessary to add a mod 8 counter that increases its value every radio symbol time. When the mod 8 count wraps around, the T1, T2, and T3 counters are incremented by 1. As a safety feature, the mod 8 counter resets to 0 every time the radio frame count is incremented by 1. The T1, T2, and T3 counters reset only when the radio timer is fully re-synchronized. Figure 5 shows how the current GSM T counter design should be changed.

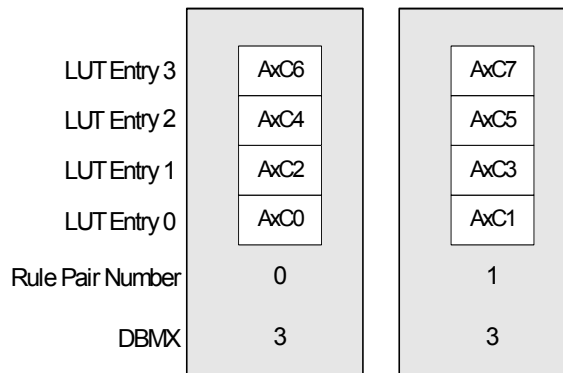
Figure 6 OBSAI Message Frame Ordering for Two Rule Pairs

For OBSAI (Open Base Station Architecture Initiative), the protocol encoder supports two kinds of transmission rules—modulo and DBRM—to interleave multiple channel data into one link. There are 64 modulo rules and 64 DBMR rules. When using both rules together they share the same index numbers. If the user sets only one modulo rule and DBMR for a specific link, it does not cause any lookup table confusion and perfectly supports multiple numbers of entries (channels) with the correct interleaving. However, if the user assigns multiple numbers of rules with multiple entries (channels), the operation does not work correctly. The lookup table index always resets to 0 after visiting the rules except for the last rule pair.

Expected framing order: **AxC0**, AxC1, **AxC2**, AxC3, **AxC4**, AxC5, **AxC6**, AxC7

Framing order of current hardware **AxC0**, AxC1, **AxC0**, AxC3, **AxC0**, AxC5, **AxC0**, AxC7

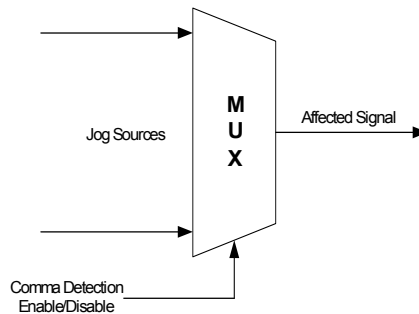
Figure 7 Affected Signal

The jog request (mux output), which is shown as Affected Signal in [Figure 7](#), is fed to a synchronizer located elsewhere in the SerDes. This signal can glitch while disabling comma detection. Depending on the PVT and line frequency, this glitch can be misinterpreted as a spurious jog request, which can corrupt the alignment. PVT dependency is such that not all devices will exhibit the issue.

All the six lanes are affected with this issue. AIF2 has two SerDes modules inside. One module has lane0 to lane3 and the other has lane4 and lane5. The glitch is dependent on layout differences between these two macros so it is possible that only some of the six lanes will show this issue and some will not.

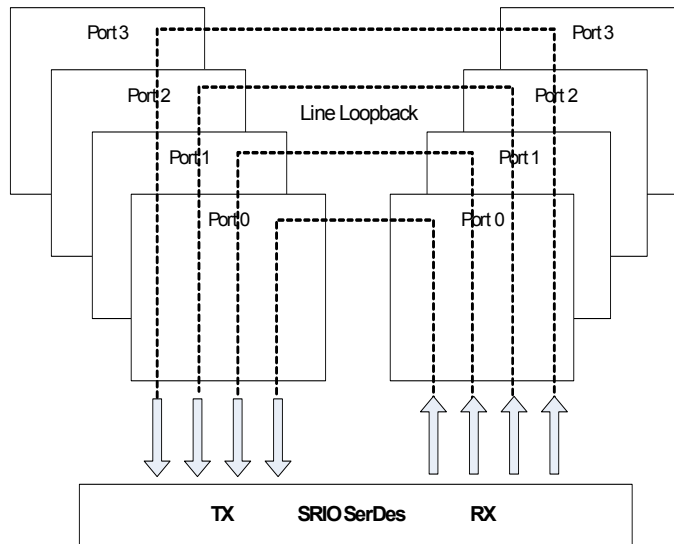
Figure 8 SRIO SerDes in Loopback Mode

The port does not provide any clock compensation when line loopback is enabled. The transmit clock must be externally synchronized with the receive clock. There is only a small FIFO that can compensate for PLL jitter or wander. Hence, correct operation of line loopback requires that the link partners use the same reference clock for the SRIO physical layer, in order to avoid overruns or underruns due to clock frequency mismatch between the link partners. As a result, line loopback mode is generally restricted to validation and qualification of board signal integrity in a lab environment.

When line loopback is enabled on one or more SRIO ports, any valid 10b code group that decodes to an illegal control character as defined by the RapidIO Specification (Revision 2.1) and whose most significant bit is 0, will be corrupted on transmission. This issue can be summarized as follows:

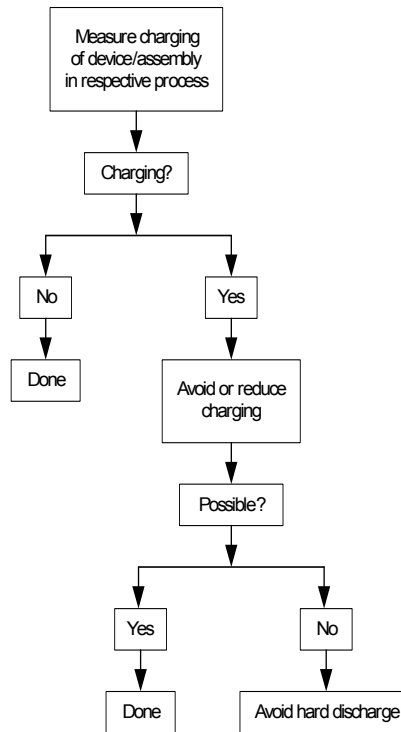
Figure 9 Basic Flow for Analyzing CDM Risk

Due to the sensitive nature of the SerDes high-speed pins, exceeding component ESD CDM stress pulses of 150 V on the functional pins listed below may cause permanent changes to the output swing and the de-emphasis behavior associated with these pins.

Workaround: While there is no strict workaround for this issue, there are several ways to analyze the risk with regards to CDM. [Figure 9](#) shows the basic flow for analyzing this risk:

Using generally accepted good practices during the assembly process can help to minimize the likelihood of a hard discharge. These practices include:

- The use of an ionizer near the PCB before, during, and after placement of parts
- The use of grounded, conductive/dissipative suction cups when using pick-and-place machines
- The use of dissipative materials for downholder pins and/or plastic covers as well as two-stage pogo-pins while performing in-circuit-test.

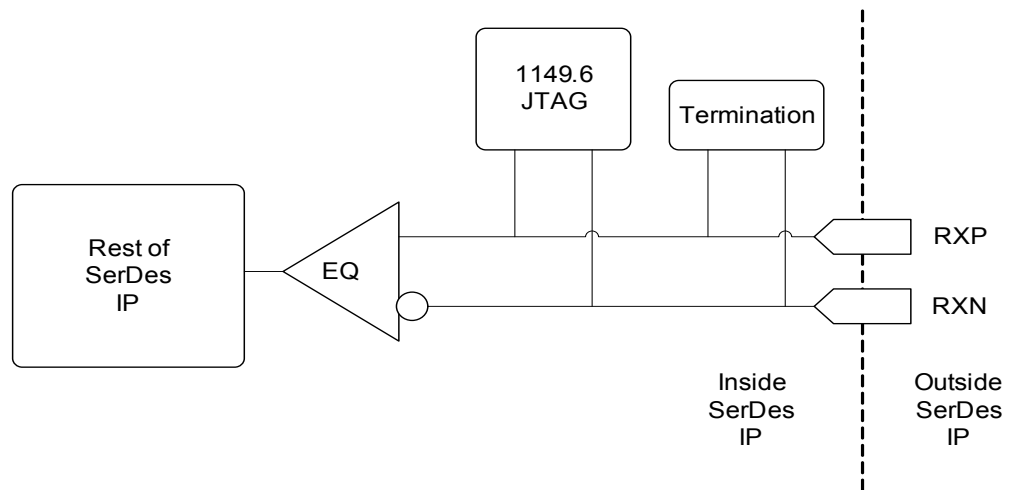
Figure 10 Simplified SerDes receiver block diagram depicting relative placement of major receiver components

A problem has been identified in some cases where the AC-JTAG (IEEE 1149.6, edge-sensitive) input cells on receivers do not reliably respond to input edge transitions from an associated transmitter. Because of this failure, the 1149.6 scan-chain users can receive faulty signal levels transitions or no transitions at all.

IEEE 1149.1, level-sensitive, input cells show no issue and normal operation of the SerDes receivers is also unaffected by this problem.

The reason for the issue is due to the original AC-JTAG input cell performance being overly sensitive to rise/fall times of the signals interfacing to it and input transition frequency.

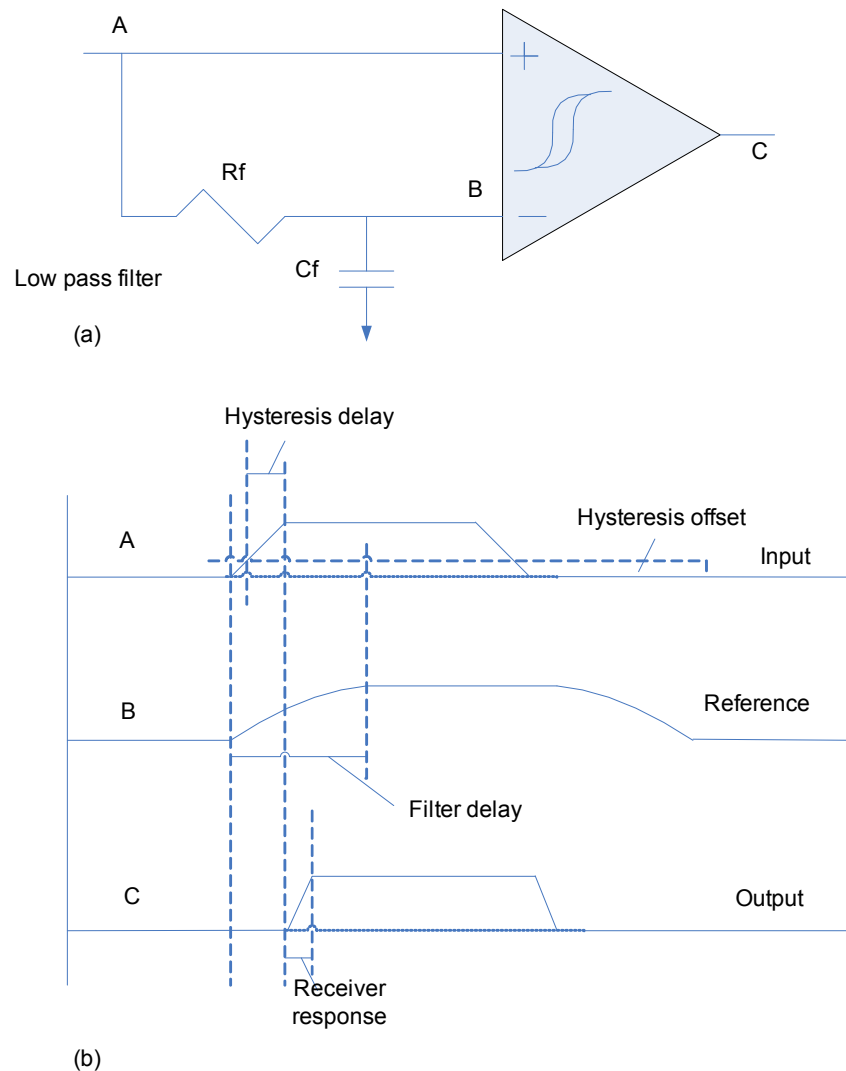
Figure 11 Self-referenced Comparator and Response (See Note Below)

When the comparator inputs are saturated the comparator gain is minimized and under certain PVT conditions (strong silicon, 125° C junction temperature, minimum VDDT), the comparator can fail to switch to the proper state, or not respond at all.

Workaround: Only one potential workaround has been identified so far. The failure mode of the AC-JTAG comparator is most pronounced by single edge transitions at low frequency as this creates the highest likelihood of the comparator inputs being saturated and switching incorrectly. More frequent transitions can result in proper switching of the comparator output.

The basic procedure is to initiate multiple edge transitions and then read the state of the RX input cell in question. However, due to the nature of the failure, the exact number would have to be determined experimentally for a given device.

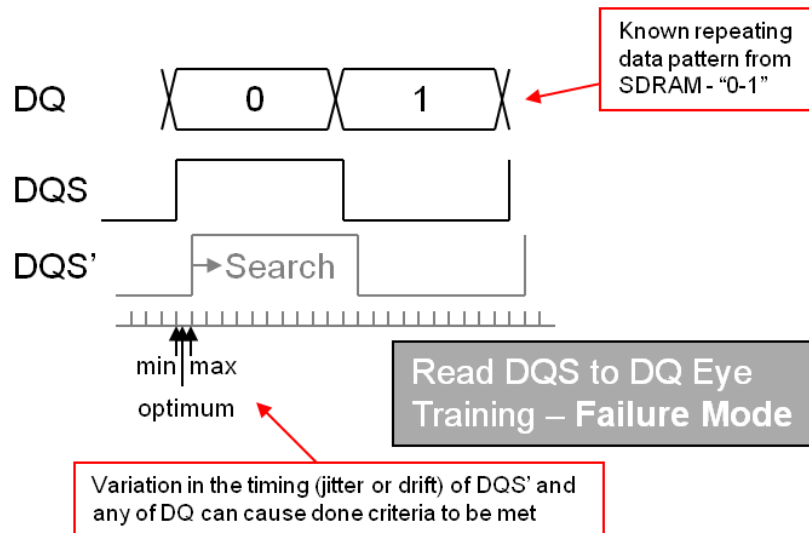
Figure 14 Read DQS to DQ Eye Training - Failure Mode

However, if too much jitter is present on the DQ or DQS signals, the search can converge to a false edge as shown in Figure 14.

This failure results in the data sampling location being placed in a very noisy transition region to the left of the DQ data eye. At this point corrupted data will then be read back to the DSP when a DDR3 read command is issued.

Workaround 1: The DDR3 PHY in the device has the ability to complete auto-leveling of the write leveling values and the read DQS gate training values separate from the read data eye training. Then a fixed value is used as the read data eye sample point. This solution is functional on standard DDR3 fly-by layouts and is referred to as Partial Automatic Leveling. It has been validated for robust operation at DDR3-1333 when connected to either a UDIMM or with a discrete SDRAM implementation.

This mode is enabled by setting bit 9 (0-indexed) of the DDR3_CONFIG_REG_23 at address 0x02620460. The lower 8 bits (bits 7:0) may be written with a read data eye sample value or left at their default value of 0x34. The default value is recommended for use. After programming DDR3_CONFIG_REG_23, proceed to enable auto-leveling. Please refer to the *DDR3 Initialization Application Report* (literature number [SPRABL2](#)) for details of the sequence of steps.

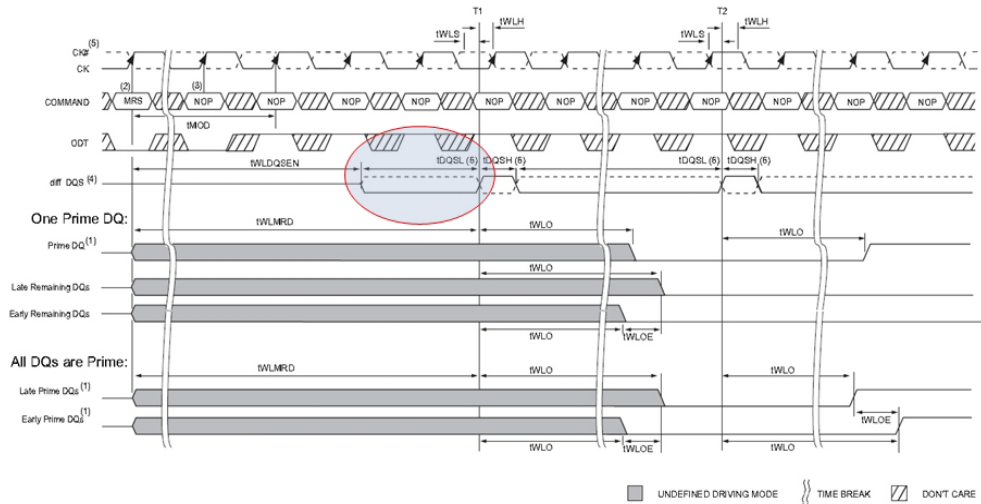
Figure 15 Timing Details of Writing Leveling Sequence

Details: As shown in Figure 15, the DDR3 JEDEC standard requires that the DQS strobe be sent with a preamble (DQS=0) for at least tDQSL during write leveling, prior to the first rising edge of the DQS strobe (DQS=1). It was observed in simulations that the first DQS strobe is sent immediately following the high impedance state of the DQS line and without a preamble. This Z->1 transition on the DQS line may allow incremental write leveling to fail. Note that this issue impacts only the incremental write leveling feature of the DDR3 Memory controller. No issue is expected with automatic write leveling.

Workaround: At this time, incremental write leveling is not supported on this device. It is recommended that the incremental write leveling intervals in RDWR_LVL_CTRL and RDWR_LVL_RMP_CTRL be programmed to 0 to disable this feature.

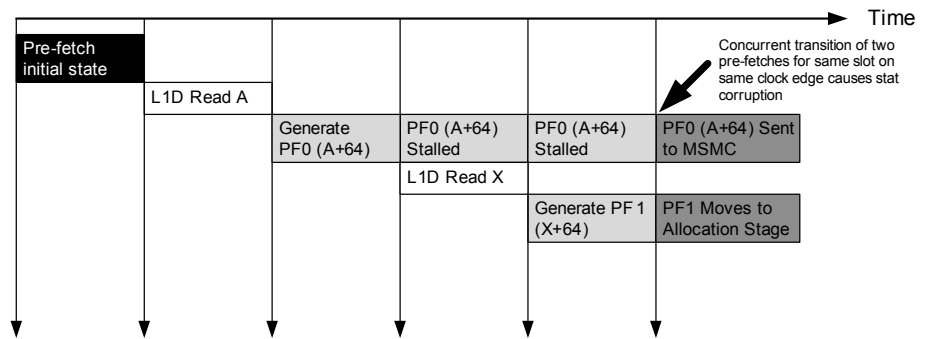
Figure 17 Sequence diagram

- a. Must be Address Hit only, both 64 byte halves of entry [0] must not contain pre-fetch data.
- b. Entry [0] must be the 'oldest' entry, next entry to reallocate.
3. Data pre-fetcher re-fetch behavior is triggered which generates pre-fetch (PF0) to A+64.
4. PF0 stalls in XMC pipeline until step 7
5. L1D pre-fetchable data read to address X hits in candidate or pre-fetch buffer, triggering allocation of entry [0] to stream starting at X+64
6. A pre-fetch for address X+64 (PF1) is generated for entry [0] early half and followed in a subsequent cycle by X+128 (PF2).
 - a. Either PF1 or PF2 can map to the same buffer slot as PF0 (this example maps PF1)
7. PF0 transitions to the XMC output (to MSMC) on the exact same clock edge that PF1 is transitioning to the buffer allocation pipeline stage

8. Instead of PF0 being marked stale and thrown away when returned, both PF0 and PF1 are marked valid and outstanding.
9. This leads to two valid outstanding pre-fetches for the same data buffer slot which is an invalid state and can result in unexpected behavior for a subsequent pre-fetchable data access to address X+64.

Depending on whether the subsequent pre-fetchable data access to X+64 arrives before or after the second pre-fetch returns, the result can be a read exception and/or data corruption. The table below describes the different possible outcomes depending on the relative timing between following events:
