OMAP4460 Multimedia Device Silicon Errata Silicon Revision 1.1, 1.0

Texas Instruments OMAP™ Family of Products

Version L

Errata

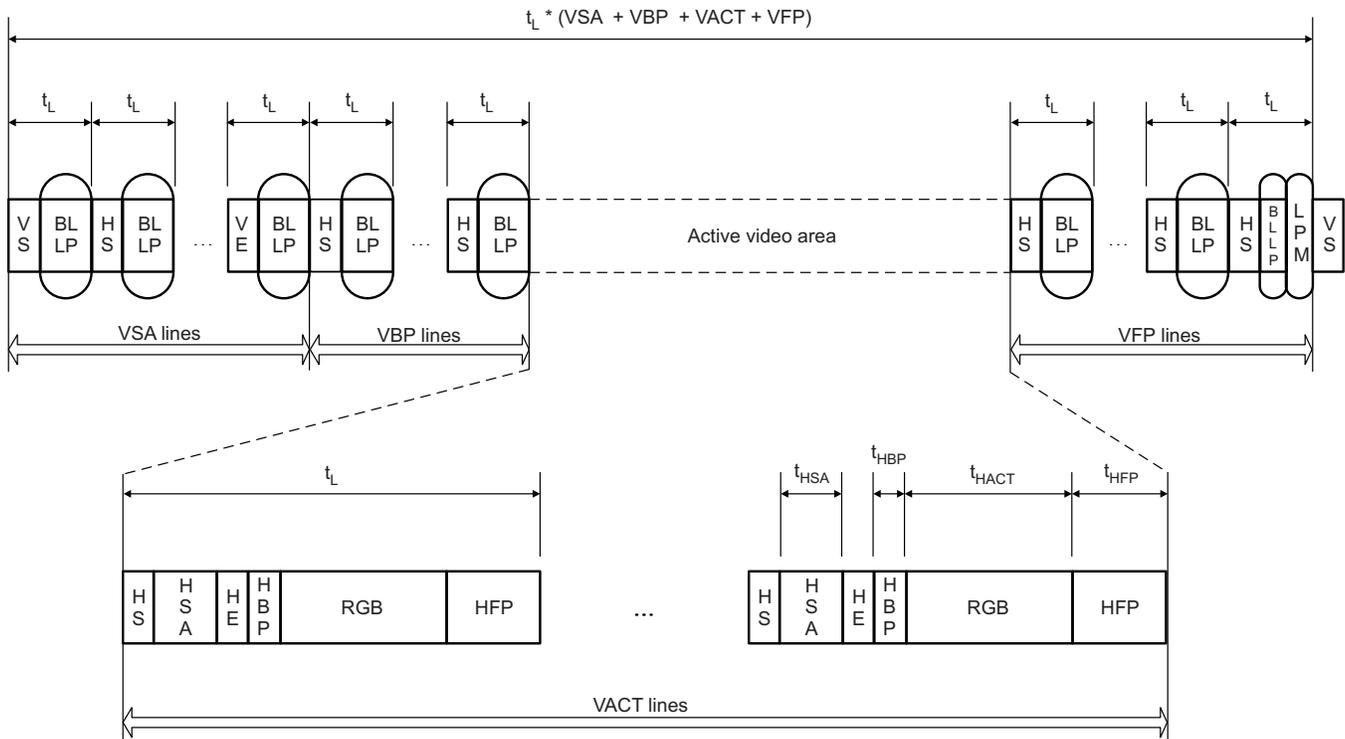
Figure 2-1. MIPI DSI 1.00 (Implemented) - Video Mode Interface Timing: Nonburst Transmission With Sync Start And End.

- The DSI protocol engine sends only HE packets (when enabled) during VACT and not during VSA, VFP, and VBP.
- The DSI protocol engine sends VE (noted as VSE in MIPI DSI ver. 1.01 specification) during VSA and not during VBP.

Figure 2.1 represents actual implementation and Figure 2.2 represents MIPI DSI ver. 1.01 specification.

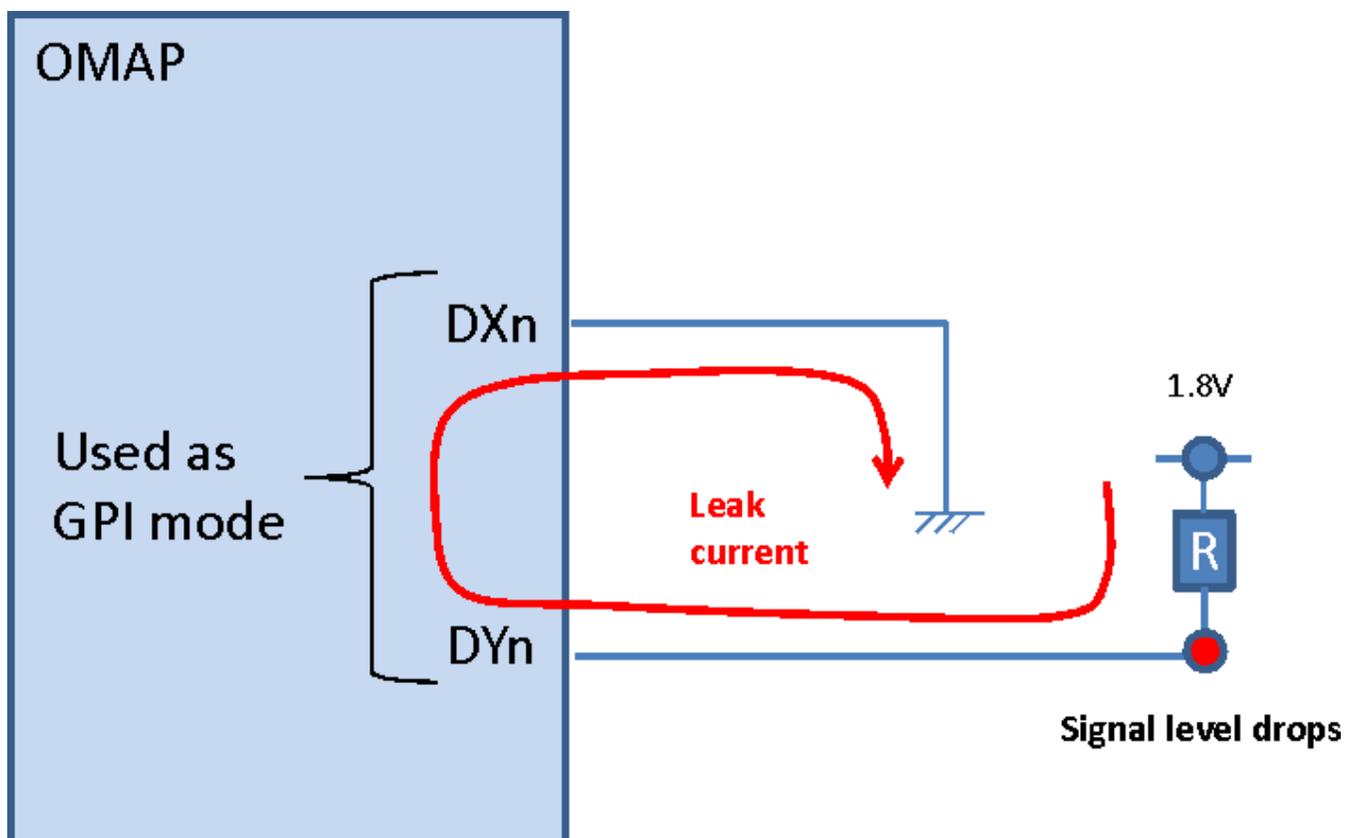
Figure 2-3. CSI PHY pad in GPI mode

The signal level of the pad which is pulled-up is dropped due to the leakage of the component used in the off switch for the on-die termination between DXn and DYn. The leakage current (and the voltage drop) varies depending on PVT condition.

Under the worst case condition, the leakage can be high enough to drop the signal level under VIH of the GPI buffer and causes functional failure.

1. Use different pad for GPI.
2. Use the pull-up resistor value smaller than or equal to 9k Ohm. It avoids the voltage drop and keeps the signal level above VIH. However this will be at the expense of increased current (up to 70uA in the worst case), as long as DXn and DYn are opposite in polarity.

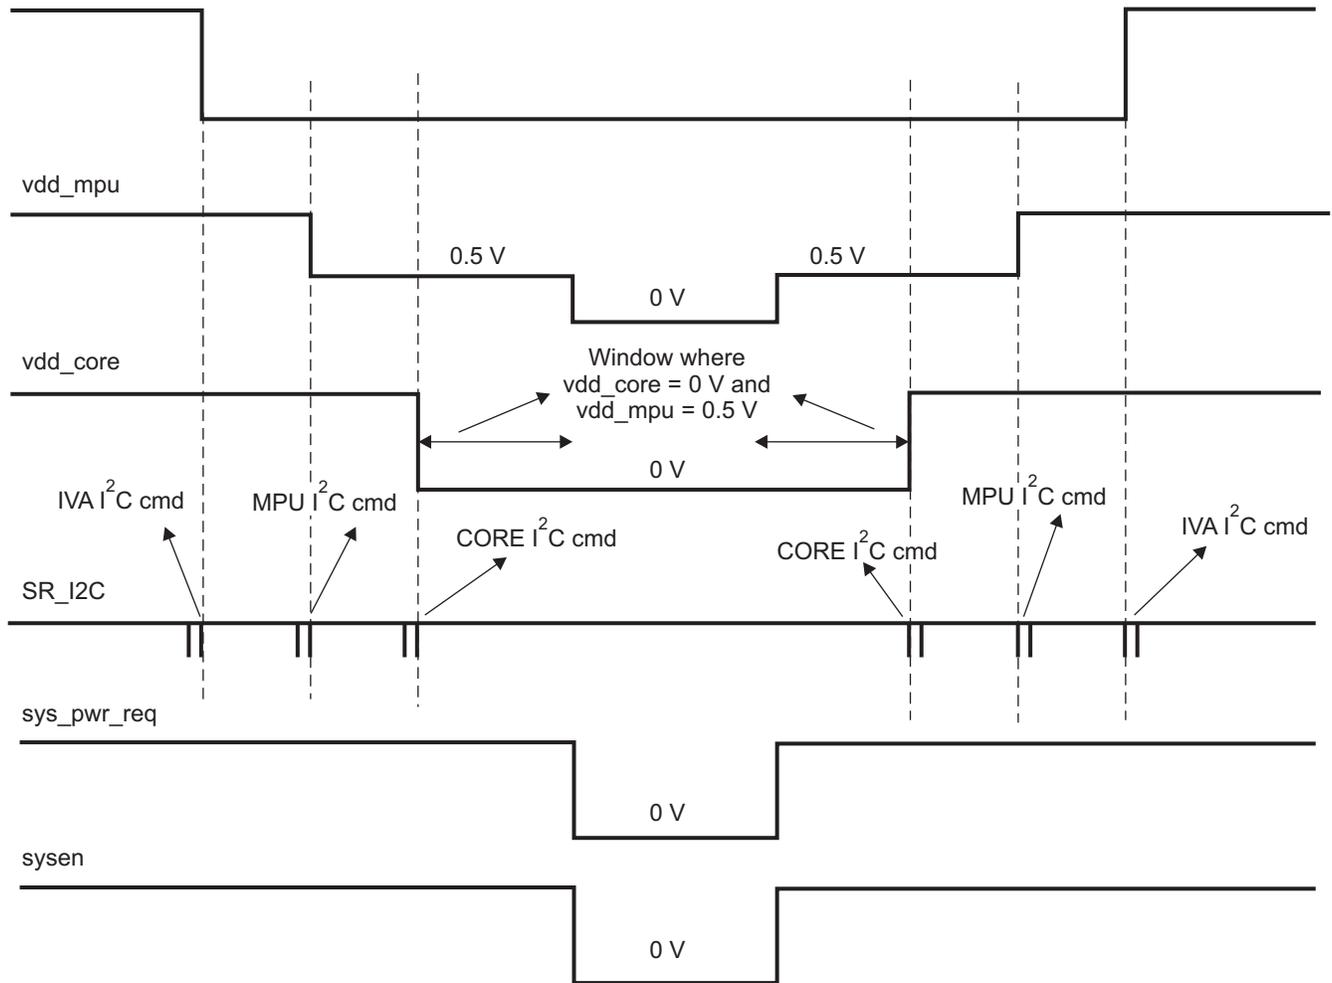
Figure 3-1. Original OMAP4xx OFF-Wakeup Sequence

This creates a window where the VDD_CORE voltage rail is 0 V and the VDD_MPU voltage is 0.5 V. This condition affects the reliability of the device, thereby reducing the lifetime of the device.

The original OMAP44xx OFF-wakeup sequence without the Guidelines is shown below.

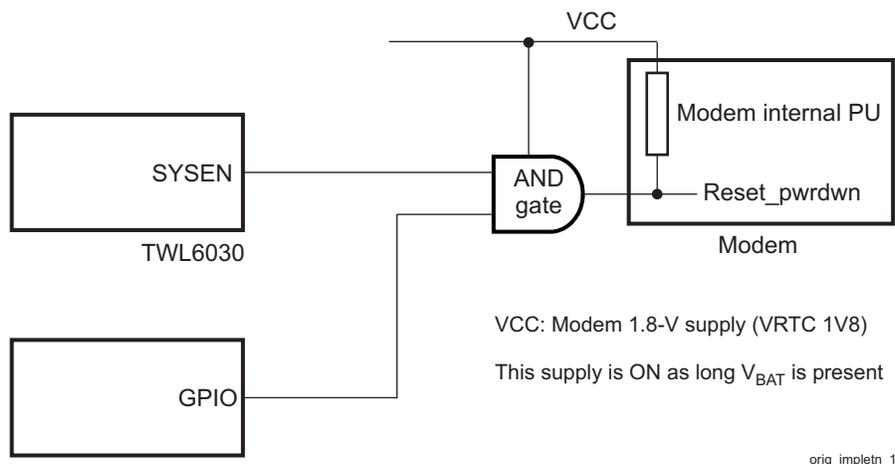
Figure 3-3. Original Implementation

The figure below shows the modem.
