# CC1020 Errata Note 001, rev. 1.0

# CC1020 Errata Note 002, rev. 1.0

# CC1020 Errata Note 003, rev. 2.0

# CC1020 Errata Note 004, rev. 1.0

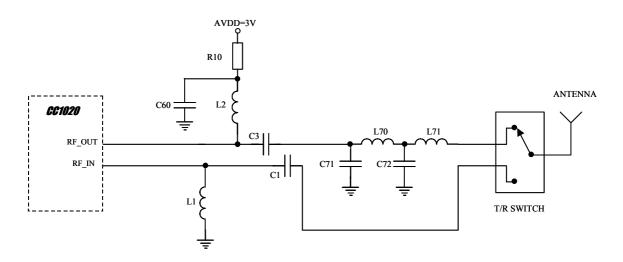
Figure 1: Schematic diagram of the input/output matching network

When using high output power settings with the CC1020EMX-433 v1.0 the recommended maximum voltage level on the RF\_OUT pin (pin 21) is exceeded. This may cause a drop in output power over time, particularly if the transmit duty cycle is high. Power drop has only been observed on the 402 – 470 MHz version of the reference design (i.e. the CC1020EMX-433 v1.0) as the 804 – 940 MHz version has a considerably lower voltage swing during transmit.

By lowering the load impedance "seen" by the CC1020 power amplifier, the output power drop is avoided. The series resistor R10 is added to reduce the DC voltage at the RF\_OUT pin. Finally, for the CC1020EMX-433 the filter topology has been changed from a  $\pi$ -type filter to a T-type filter in order to achieve a better combination of reflection factors for the harmonics. This change applies to the 433 MHz frequency only. Altogether, these changes, which are implemented in the new CC1020EMX reference design v2.0, remedy the output power drop problem. The new solution increases the current consumption in transmit mode by typically 3 mA at maximum output power.

For future designs, Chipcon recommends using the most recent CC1020EMX reference design (v2.0 or higher), which is available on web at <a href="https://www.chipcon.com">www.chipcon.com</a>. The matching components for this reference design are shown in <a href="figure 1">Figure 1</a>. For 804 – 940 MHz, no changes to legacy v1.0 based designs are necessary. However, the resistor R10, as shown in <a href="figure 1">Figure 1</a>, will be included in all future CC1020EMX reference designs (please note that from v2.0 there is one common PCB design supporting all of the 433/868/915 MHz frequency bands).

Copy the CC1020EMX reference design v1.1 (4-layer), v2.0 (2-layer) or newer.

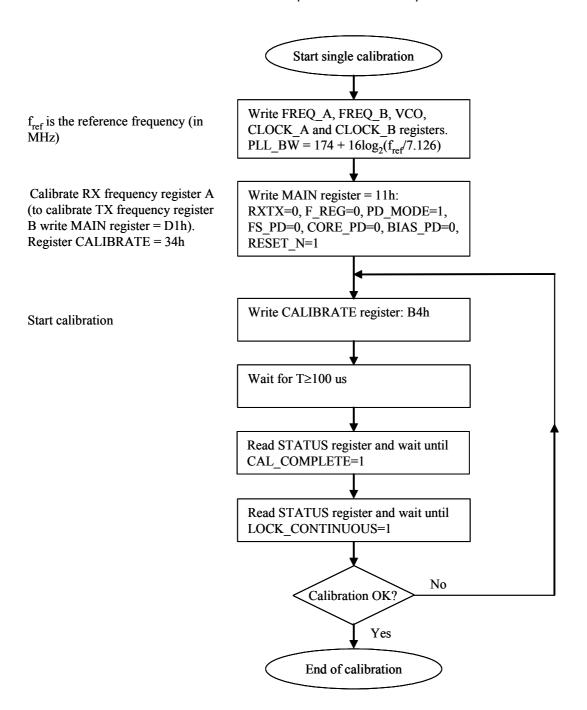
Figure 1: Recommended PLL calibration procedure

When using a 14.7456 MHz crystal frequency the CC1020 calibration (monitored by steps 2 and 3) typically lasts 27 ms. However, it has been observed that the CAL\_COMPLETE indicator in the STATUS register is unreliable <u>during</u> the first 100 µs after initiating the calibration. As a result step 2 might indicate calibration complete too early, i.e. before the actual calibration has actually completed. In such a situation step 3 (LOCK monitoring) is executed <u>during</u> instead of <u>after</u> calibration. In order to avoid this inconsistency, a waiting period of at least 100 µs between calibration start and the start of the polling should be applied using one of the following methods:

In less than 10 ppm of all PLL calibrations performed it was observed that CC1020 did not achieve LOCK even when introducing a 100 µs wait period before polling of [STATUS.CAL\_COMPLETE] was initiated. The reason for no LOCK still occurring, even when calibrating the PLL with this small wait period, is due to the PLL calibration procedure making an erroneous frequency measurement causing the PLL calibration algorithm to choose a wrong capacitor array setting producing a no LOCK situation. For this reason it is important to control that the PLL calibration achieves LOCK and recalibrate if it does not.

For those users who have not already implemented a recalibration procedure in software it is strongly recommended to avoid polling [STATUS.CAL\_COMPLETE] until 100 µs has elapsed following calibration start, then monitor LOCK after calibration complete and, if LOCK is not achieved, recalibrate until LOCK is successfully achieved. The recommended calibration procedure, including recalibration, is provided in figure 1.
