## 1 Introduction

This document describes the known exceptions to the functional and performance specifications to TI CMOS Radar Devices (IWR6432AOP )

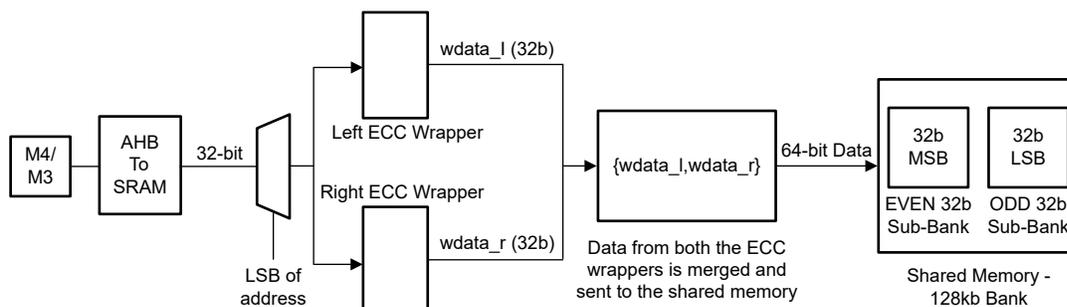
**Figure 5-1. Shared Memory Logic Diagram When Shared with M4/M3**

Internal shared memory has ODD and EVEN banking structure. For a particular address range, partial write (less than 32 bit) to EVEN bank corrupts same address of ODD bank with next data on the bus. When shared memory is allocated to M4/M3, back to back full word write access to location A followed by sub-word write access to location B corrupts data in location A.

When memory is shared with M4/M3, issue is seen in the following address range:

When shared with M3/M4, the incoming data bit width is 32 bit as shown in the diagram. So, depending on LSB of address, signals are sent to either left or right ECC wrapper.

1. Use shared memories as code memory when shared with processor.
2. Disable ECC for non functional safety devices – ECC is disabled for shared memories in RBL for non functional safety devices.
