MSP430F5638 Device Erratasheet

The revision of the device can be identified by the revision letter on the [Package Markings](#) or by the [HW_ID](#) located inside the TLV structure of the device

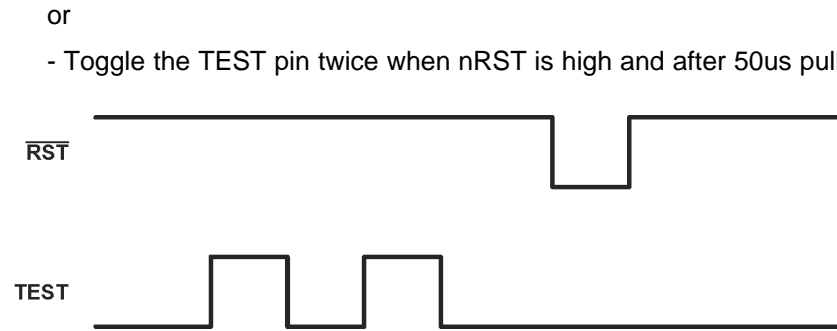
Description The methods used to exit the BSL per MSP430 Programming Via the Bootstrap Loader ([SLAU319](#)) are invalid.

Workaround To exit the BSL one of the following methods must be used.
- A Power cycle

Note: This toggling of TEST pins is not subject to timing constraints. The appropriate level transitions on TEST pin, followed by a RST pulse after 50us, are sufficient to trigger an exit from BSL mode.
