MSP430FE427 Device Erratasheet

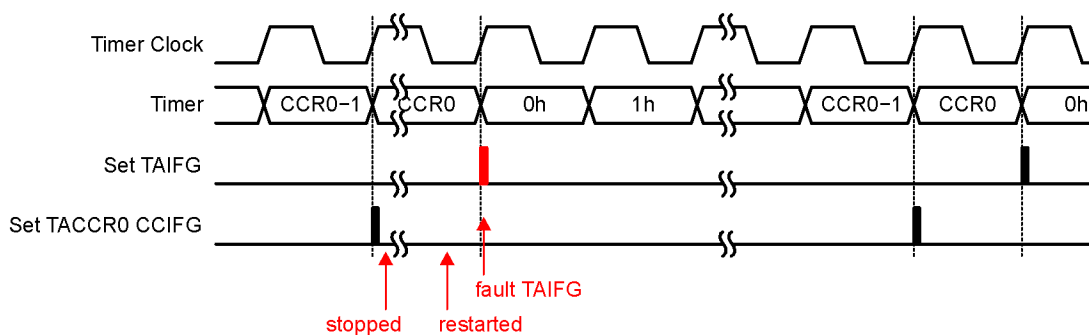
TA21 *TIMER_A Module*

Function TAIFG Flag is erroneously set after Timer A restarts in Up Mode

Description In Up Mode, the TAIFG flag should only be set when the timer counts from TACCR0 to zero. However, if the Timer A is stopped at TAR = TACCR0, then cleared (TAR=0) by setting the TACLK bit, and finally restarted in Up Mode, the next rising edge of the TACLK will erroneously set the TAIFG flag.

Workaround None.
