TMS320DM816x DaVinci™ Digital Media Processors

Silicon Revisions 2.1, 2.0, 1.1, 1.0

Silicon Errata

Literature Number: SPRZ329F
November 2010–Revised March 2015

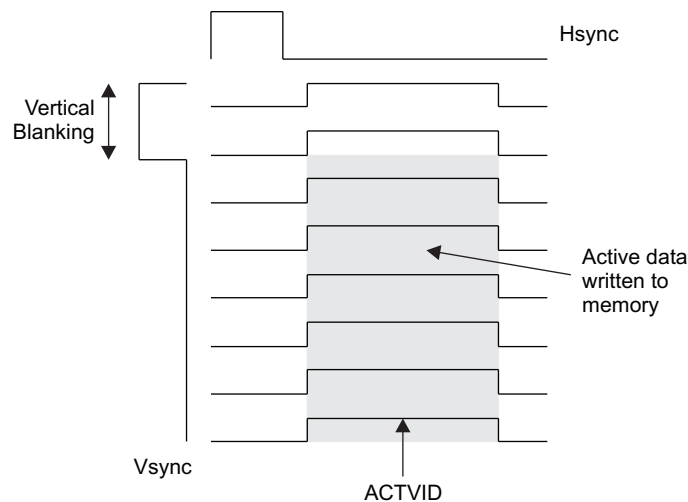
Figure 3. ACTVID Signal Active for All Lines of Incoming Data

Details: The VIP port supports a discrete sync capture mode where the ACTVID signal is used to determine the active region of the video and then the VPDMA writes this active video frame to memory. However, with some external video decoders, this mode does not work by default.

Workaround: The VIP parser requires that the ACTVID signal is active for all lines of the incoming data, including the vertical blanking region. The vertical blanking region, itself, is not written to memory by the VPDMA. [Figure 3](#) illustrates this.

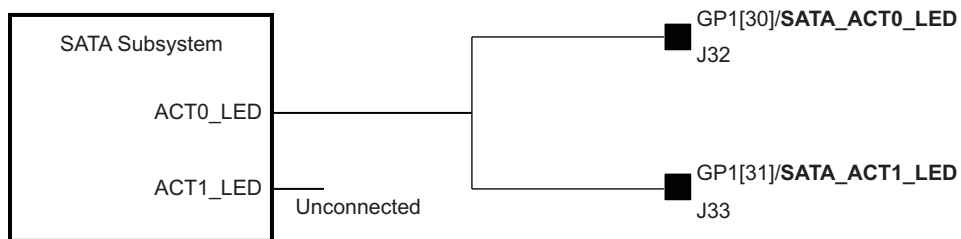
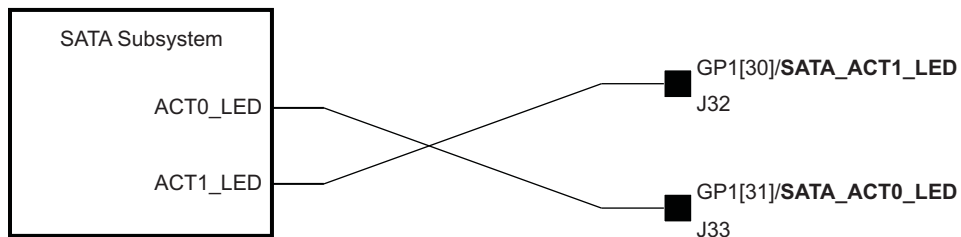
Figure 4. SATA Activity LED Connectivity

This issue is corrected on revision 2.0, but with the output pins reversed. SATA_ACT1_LED is mapped to pin J32 and SATA_ACT0_LED to pin J33 (see [Figure 4](#)).
