DRA75x, DRA74x SoC for Automotive Infotainment Silicon Revision 2.0, 1.1

Errata

Literature Number: SPRZ398K
NOVEMBER 2012 – REVISED SEPTEMBER 2024

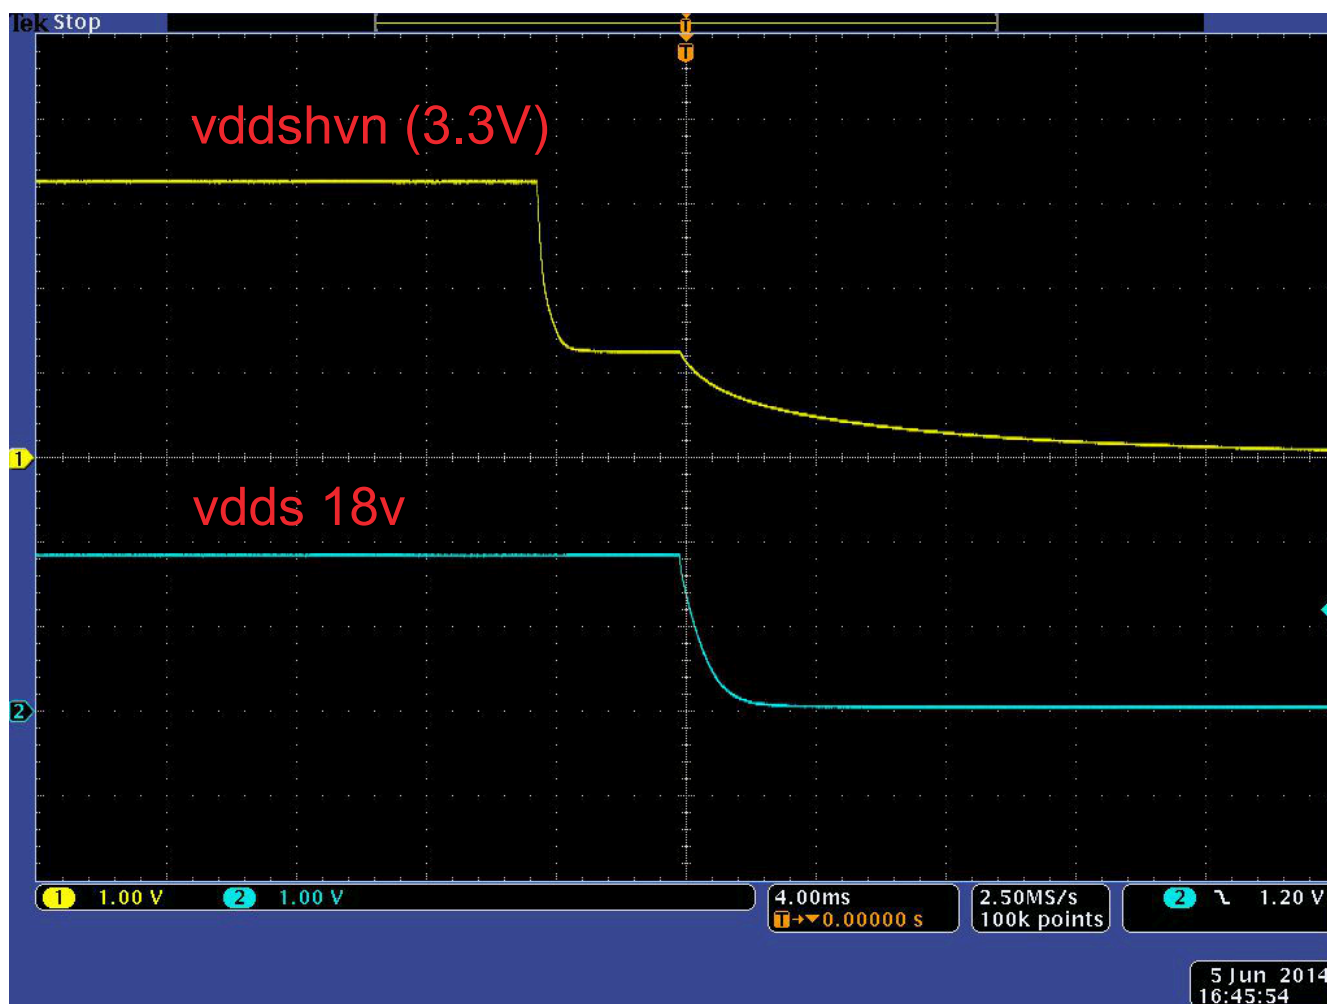
Figure 4-1. PAB_RevA

The Data Manual allows the vddshvn rail (in either 3.3V or 1.8V mode) to power down at the same time or before the vdds18v rail. When the vddshvn rail is powered down before the vdds18v rail, the vddshvn rail stays at Plateau Level (<1.5V) until the vdds18v rail is disabled, as shown in the waveform below.

A subset of the SOC's LVCMOS IOs (refer to DM for details) have a pull-up resistor that is active by default, including during reset and power-down. The SOC's IOs that have internal or external pull-ups will stay at Plateau Level (<1.5V) during the power-down. If other ICs on the board that are interfaced to the SOC's LVCMOS signals use a separate supply then it's possible that the other IC's signals can be pulled to the Plateau Level while its power supply is off.

The root cause of the plateau is related to the LVCMOS IO buffer Dual Voltage detection circuitry. The LVCMOS Dual Voltage IO includes voltage comparator circuitry to determine

In general, TI recommends using the same supply source for connected components. E.g., a single LDO should drive vddshvn and the related 3.3V external components.

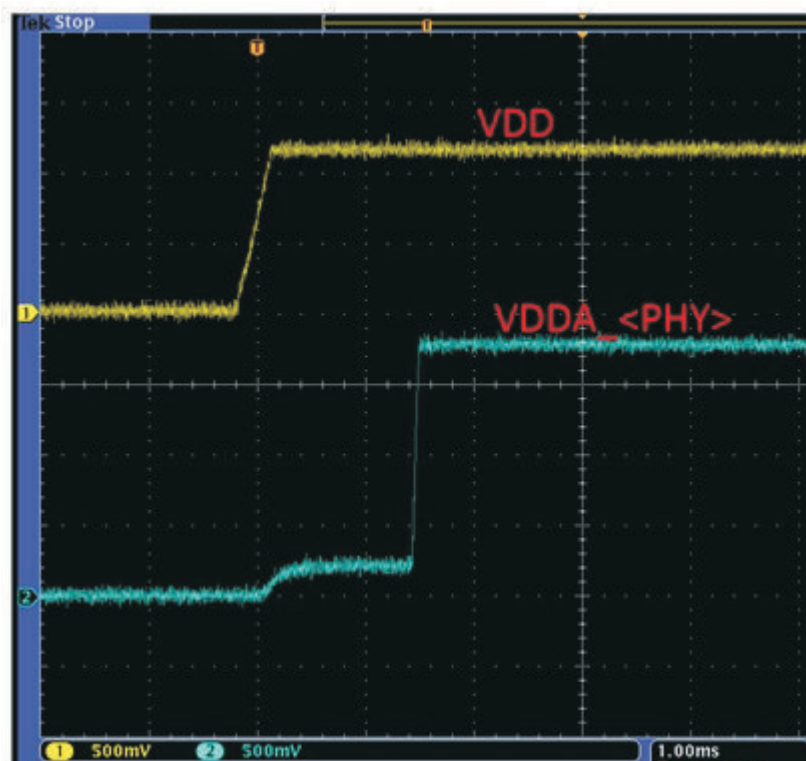
Figure 4-2. Leakage Voltage

A current path exists between VDD and the high speed analog PHY domain (VDDA_HDMI, VDDA_PCIE, VDDA_SATA, VDDA_USB2/3) during the supply power up and power down sequences.

The device-specific Data Manual requires Core AVS rail (VDD) to power up before the 1.8 V high speed analog PHY domain(s). When this sequence is followed, the high speed analog PHY domain will have a small step-up to a voltage plateau (< 0.5 V) that aligns to the beginning of the VDD ramp-up, and is maintained until the ramp-up of high speed analog PHY rail, as shown in [Figure 4-2](#). Note the leakage value will differ from system to system, but will be less than 500 mV. The leakage voltage in the provided capture is approximately 250 mV.

A similar condition exists during supply power down sequence. The high speed analog PHY domain(s) are required to be powered down prior to Core AVS rail (VDD), and may cause a small plateau to exist until Core AVS rail (VDD) is ramped down.

The root cause of the voltage plateau during power-up/down sequencing is related to the parasitic diodes in logic blocks which have multiple power sources. This leakage path is not a reliability concern for this device.
