# J721E DRA829/TDA4VM Processors Silicon Revision 1.1/1.0

## ABSTRACT

This document describes the known exceptions to the functional specifications (advisories). This document may also contain usage notes. Usage notes describe situations where the device's behavior may not match presumed or documented behavior. This may include behaviors that affect device performance or functional correctness.

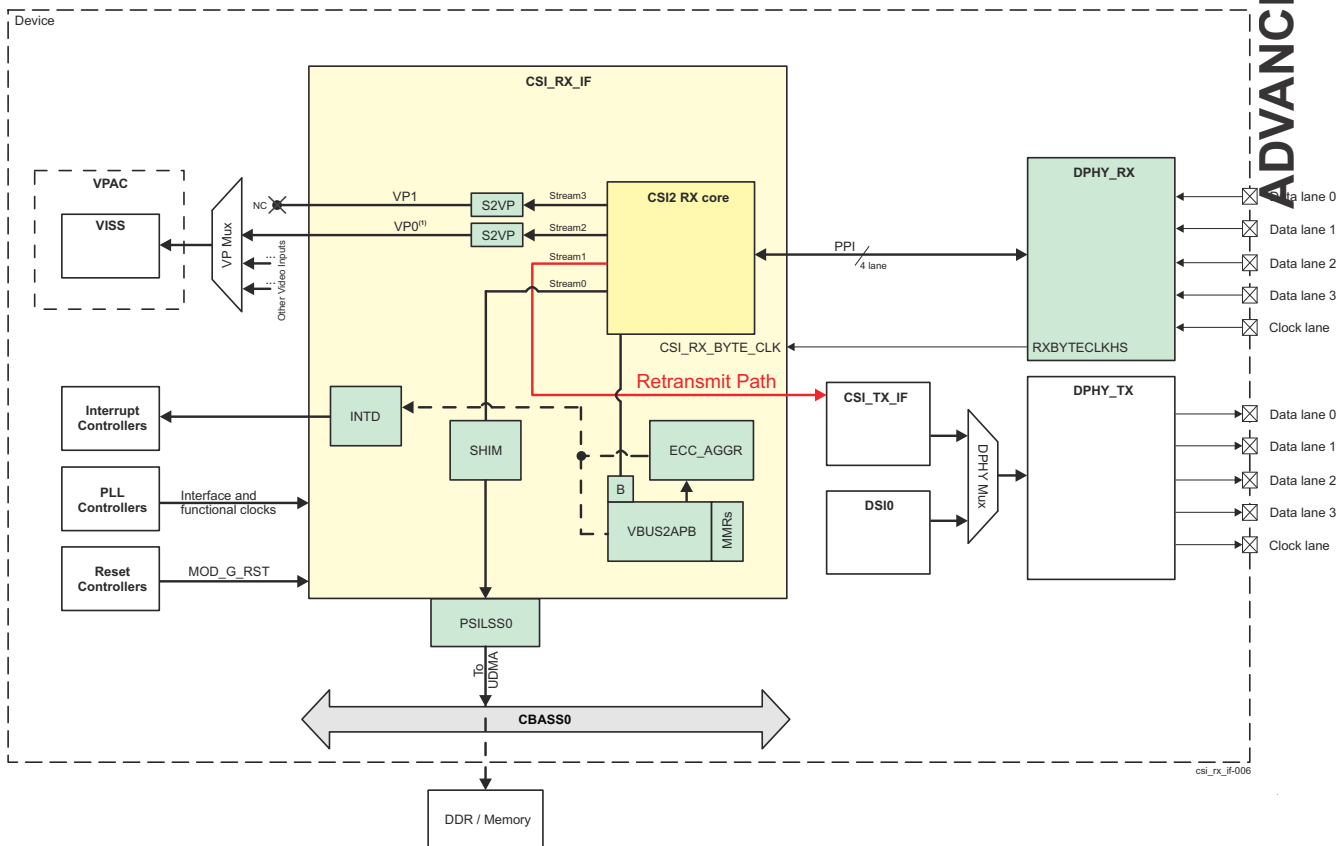
**Figure 3-1. CSI\_RX\_IF Block Diagram**

CSI\_TX\_IF module does not recognize blanking in input data. Given all sensors are expected to have blanking, the re-transmit path between CSI\_RX\_IF module and CSI\_TX\_IF module cannot be used.

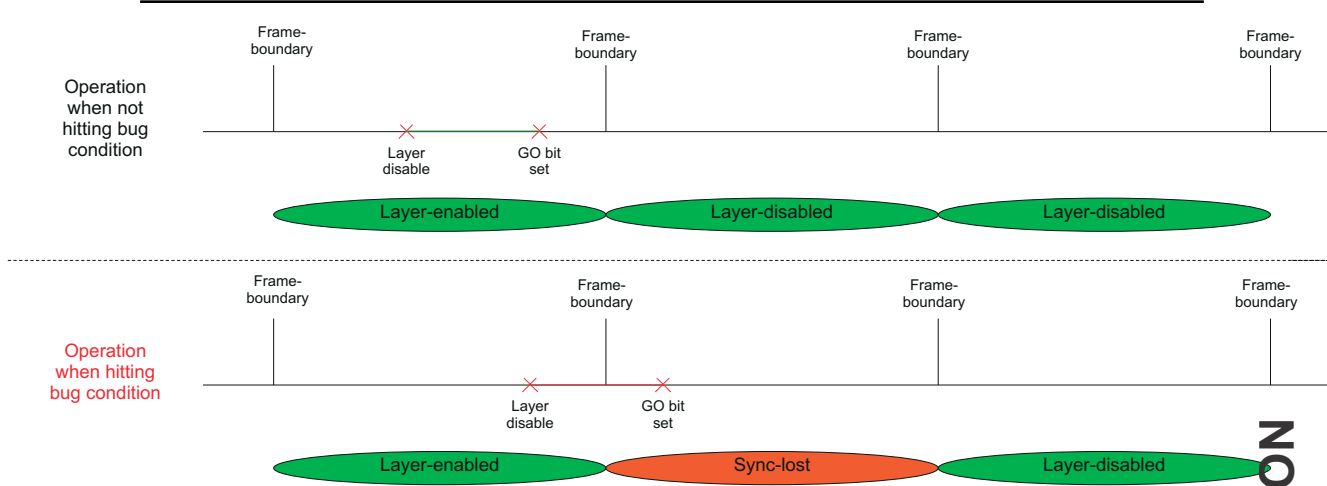
**Figure 3-2. Bug Condition**

- 
- i2097**                      ***DSS: Disabling a Layer Connected to Overlay May Result in Synclost During the Next Frame***
- 
- Details:**                      Disabling a layer (for example VID1) connected to an OVR (that is toggling DSS\_VID\_ATTRIBUTESx[0] ENABLE from 1 to 0) may result in synclost during the next frame. The synclost may result in a corrupted or blank frame (all pixel data sent out of DSS during the frame is 0x0). The occurrence of synclost is dependent on the timing of setting the GO bit (that is DSS\_VP\_CONTROL[5] GOBIT to 1) vis-à-vis the disabling of the layer. If the “disable layer” MMR write operation and “set GO bit” MMR write operation happens within the same frame boundary, no synclost occurs. If the operations happen across the frame boundary, then synclost occurs (for one frame). The design automatically recovers and returns to normal operation from the next frame after GO bit is set, see [Figure 3-2](#).

**Workaround(s):** A simple software workaround exists. In the workaround, prior to disabling a layer on the OVR, it is moved to the “non-visible” area of the OVR (for example: `DSS_OVR_ATTRIBUTES_x[17-6] POSX = max_value_of_posx` or `DSS_OVR_ATTRIBUTES_x[30-19] POSY = max_value_of_posy`). This avoids the synclost when the layer is disabled.
