# Errata AM263Px Sitara™ Microcontroller Silicon Revision

### Abstract

This document describes the known exceptions to the functional specifications (advisories). This document may also contain usage notes. Usage notes describe situations where the device's behavior may not match presumed or documented behavior. This may include behaviors that affect device performance or functional correctness.

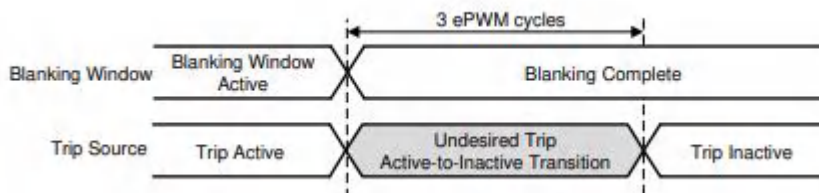
The blanking window is typically used to mask any PWM trip events during transitions which would be false trips to the system. If an ePWM trip event remains active for less than three ePWM clocks after the end of the blanking window cycles, there can be an undesired glitch at the ePWM output.

The following picture illustrates the time period which could result in an undesired ePWM output.

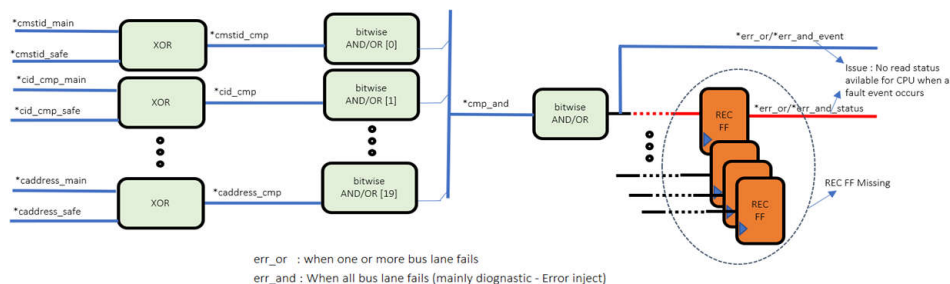
**Figure 2-1.**

Case 2: Log Registers have all zeros

Here the granular logs are not captured correctly and possible entities affected are R5F and L2 memory.

Case 2: In the case where the logs are not captured correctly then for a) diagnostics no action needed and b) in case of actual failure in the application WarmResetn should be used.

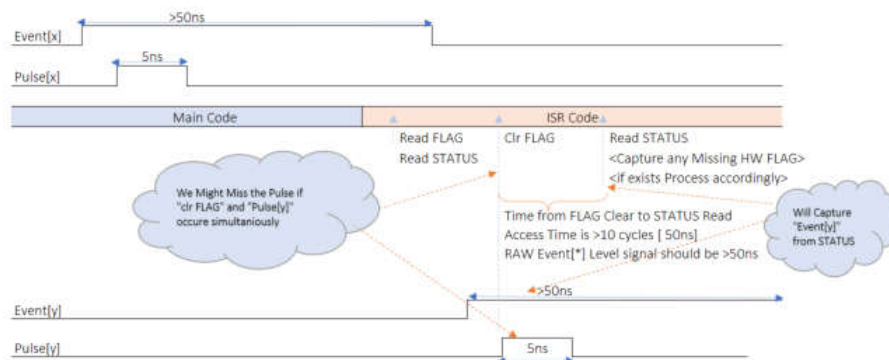
***CONTROLSS: Race condition OUTPUT\_XBAR and PWM\_XBAR resulting in event miss***

Potential race condition in capture registers resulting in events getting lost while other events in the same register are being cleared by writing to the register. Following registers are impacted by this issue:

Capture any missing HW event FLAG

If exists, process accordingly

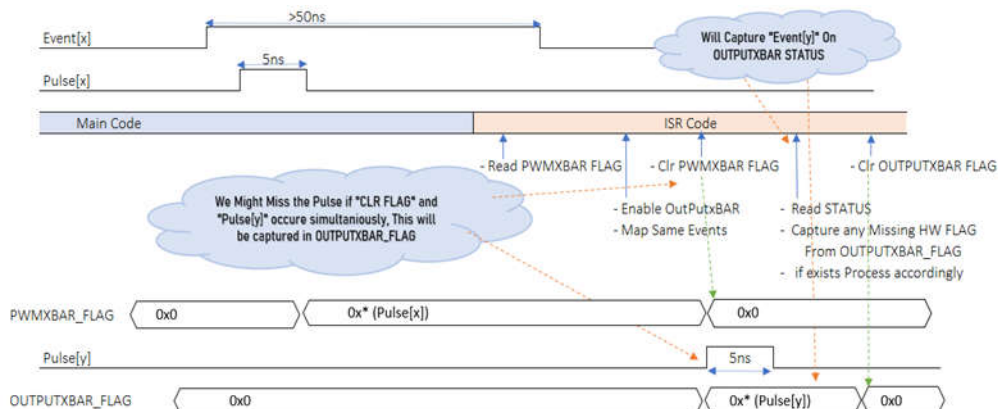
## **CONTROLSS: Race condition OUTPUT\_XBAR and PWM\_XBAR resulting in event miss**

- Clr FLAG, Event[y] OutputXBAR

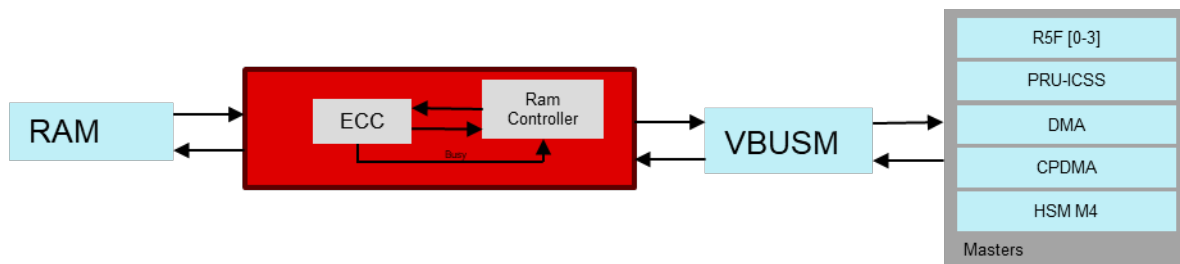
- When a single-bit error is detected during a burst read, the ECC module inserts a BUSY cycle in between.
- In this BUSY cycle, the next read from memory is halted and a corrected write back is performed to fix the error in RAM.
- The BUSY signal generated during this process is improperly handled by the Bus Protocol logic.
- Upon resuming the burst read, the data pipeline becomes misaligned.

- Incorrect data is returned to the initiator for reads following error correction.
- May cause program execution failures and abort exceptions.

This issue affects only L2 and MBOX RAM read operations.

The physical RAM contents remain properly corrected (no memory corruption) and write operations function normally. Below is the high level block diagram.
