# CC2340R SimpleLink™ Family of 2.4GHz Wireless MCUs

This document describes the known exceptions to functional specifications (advisories) to the CC2340R SimpleLink™ Family of 2.4GHz Wireless MCUs.

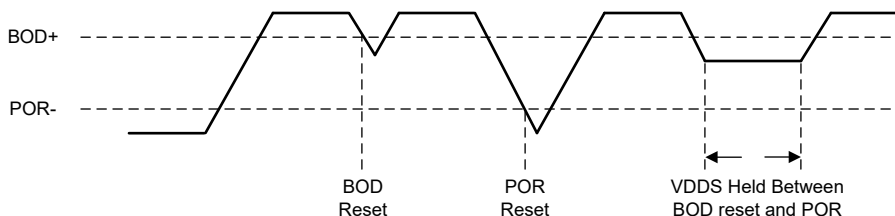
**Figure 3-1. Diagram Showing Occurrence**

If the VDD5 supply voltage is held in the BOD threshold region (approximately 1.68V), the device might, on rare occasions, enter a lock-up state. In this state, the device draws approximately 2.25mA of current and will not recover even if the VDD5 supply voltage is subsequently increased above the BOD threshold. Recovery from this state requires either a pin reset or reducing the VDD5 supply voltage below the power-on reset (POR) threshold (1.0V), thereby triggering a POR reset.

The lock-up state is triggered if a brown-out-detect (BOD) event occurs during specific stages of boot code execution. There are two critical narrow time windows, each of approximately 10 ns duration, and both of these time windows occur within 100 μs to 1 ms after the reset event that initiates the boot code. The issue typically arises when the supply voltage ramps slowly across the BOD threshold. In such cases, supply resistance in combination with device startup current may cause the VDD5 voltage to repeatedly dip below the BOD threshold as the device resets, increasing the likelihood of entering the lock-up state.

The specified operating supply voltage range for the device is 1.72V to 3.8V. When using rechargeable batteries, the battery protection system must ensure one of the following:

- The device supply voltage remains at or above the minimum operating supply voltage (1.72V) once powered on, or
- If the device supply is discharged below the minimum operating supply voltage (1.72V), the device must be reset (pin or power-on reset) when the supply is charged above the minimum operating supply voltage (1.72V) again.
