IWR6432 Device Silicon Errata

Silicon Revisions 1.0 and 2.0

ABSTRACT

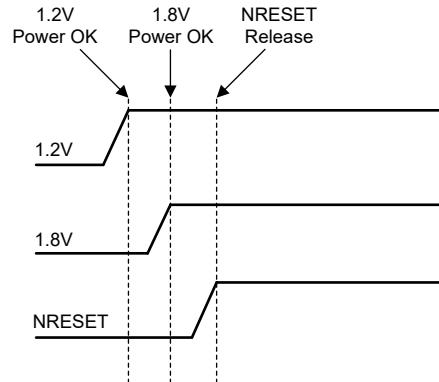
Figure 4-1. Recommended power up sequence

When the device is in power optimized topology and 1.8V powers up before 1.2V, a momentary large current can be seen at 1.2V rail before NRESET release only during the device power up. To avoid that, power up 1.2V (VDDIN, VDD_SRAM and VNWA) before 1.8V .

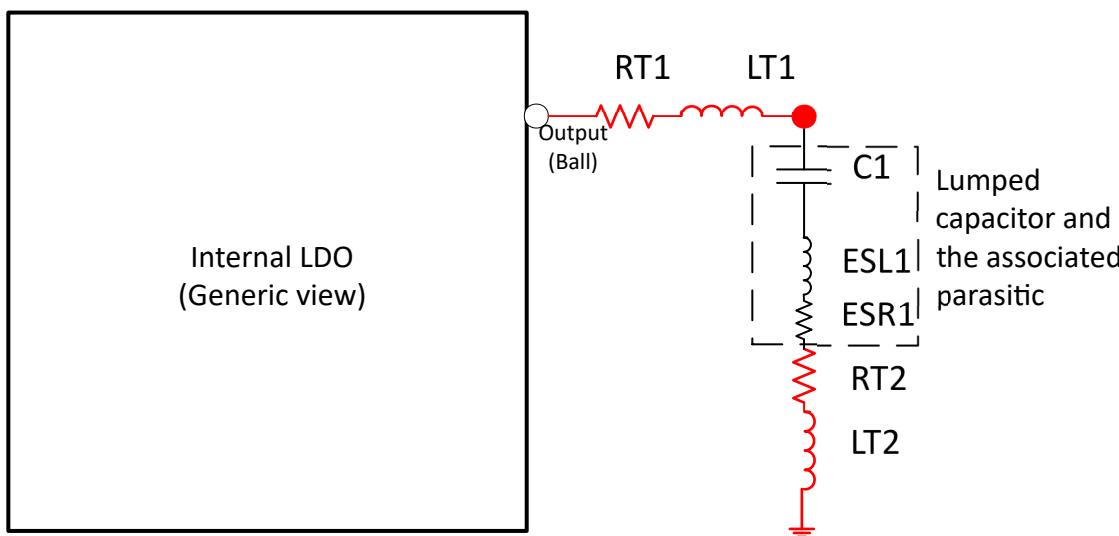
Figure 4-2. Single decoupling capacitor associated PCB parasitic

As indicated in the device data sheet, 1.2V Digital LDO requires one decoupling capacitor with a typical value of 4.7uF. The parasitic offered by different portion of the output path is illustrated in Figure 4-2. "RT1" and "RT2" are parasitic resistances offered by the ball to capacitor lead trace and the ground trace, respectively. Similarly, "LT1" and "LT2" are parasitic inductances offered by the ball to capacitor lead trace and the ground trace, respectively. "ESL1" and "ESR1" are the effective series inductance and resistance of the decoupling capacitor. Table 4-1 gives the minimum, maximum and typical values of the capacitance and the parasitic.

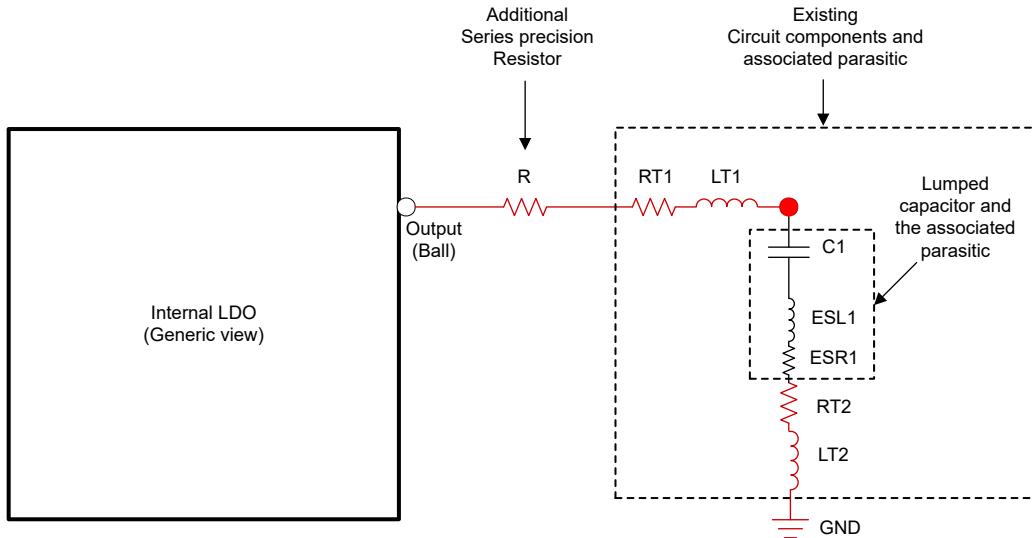
**Figure 4-3. Example workaround**

If the R_p is not achievable in PCB design, below workarounds can be considered:

Add a series precision resistor in the VDD output path along with the decoupling capacitor to get equivalent effective series resistance of the output path within the data sheet limits.

Example part no.: PA0402FRL570R02L, 20mOhm, 1% Tol.; MFL0603R0200FA, 20mOhm, 1% Tol;

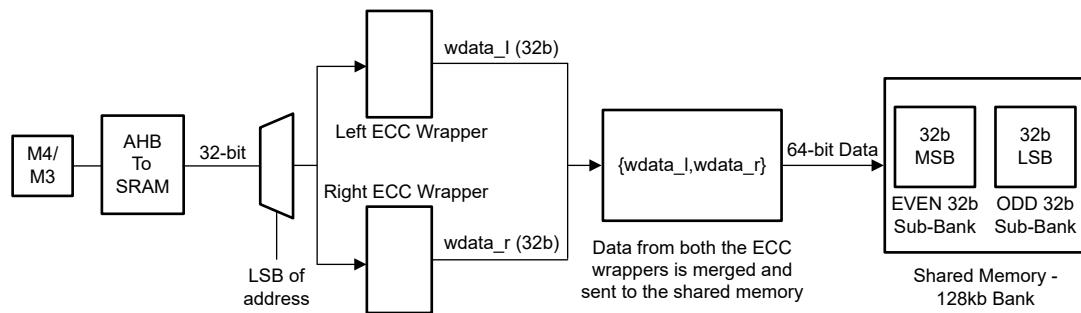
Figure 6-1. Shared Memory Logic Diagram When Shared with M4/M3

Internal shared memory has ODD and EVEN banking structure. For a particular address range, partial write (less than 32 bit) to EVEN bank corrupts same address of ODD bank with next data on the bus. When shared memory is allocated to M4/M3, back to back full word write access to location A followed by sub-word write access to location B corrupts data in location A.

When shared with M3/M4, the incoming data bit width is 32 bit as shown in the diagram. So, depending on LSB of address, signals are sent to either left or right ECC wrapper.

1. Use shared memories as code memory when shared with processor.
2. Disable ECC for non functional safety devices – ECC is disabled for shared memories in RBL for non functional safety devices.
