## ABSTRACT

This document describes the known exceptions to the functional specifications (advisories).

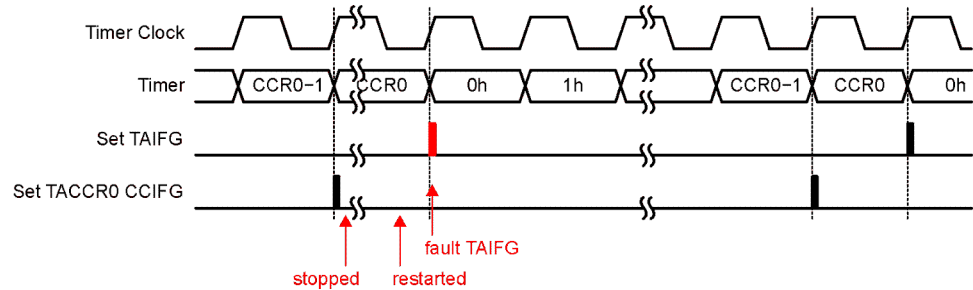
**TA21** *TA Module*

**Function** TAIFG Flag is erroneously set after Timer A restarts in Up Mode

**Description** In Up Mode, the TAIFG flag should only be set when the timer counts from TACCR0 to zero. However, if the Timer A is stopped at TAR = TACCR0, then cleared (TAR=0) by setting the TACLRL bit, and finally restarted in Up Mode, the next rising edge of the TACLK will erroneously set the TAIFG flag.

**Workaround** None.

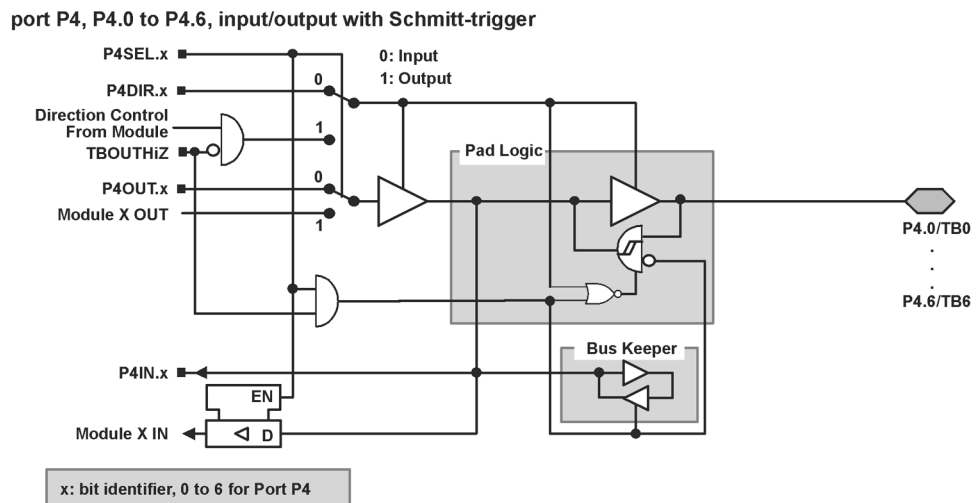
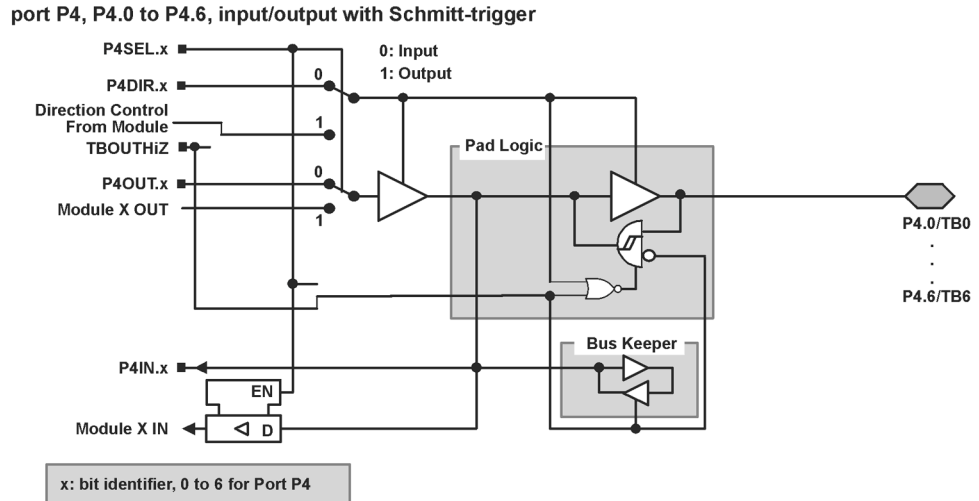
**TB3** ***TB Module***

**Function** Timer\_B Port is switched to 3-state independent of selected function

**Description** Incorrect 3-state function of Ports P4.0/TB0 through P4.6/TB6 (TBoutHiZ control). If TBoutHiZ is set to high, all ports P4.0/TB0 through P4.6/TB6 are set to 3-state, independent of the P4SEL.x control signals. This means a port P4.x is switched to 3-state with TBoutHiZ, even if it is not selected for Timer\_B function. In addition, the ports P4.0/TB0 through P4.6/TB6 are switched to 3-state with TBoutHiZ, even if the port direction (direction control from module) is set to input. This is in accordance with the specification description but, nevertheless, is an unexpected behavior.

Port function as specified

Port Realization With TB3 Bug

**Workaround** No workaround.
