ABSTRACT

This document describes the known exceptions to the functional specifications (advisories).

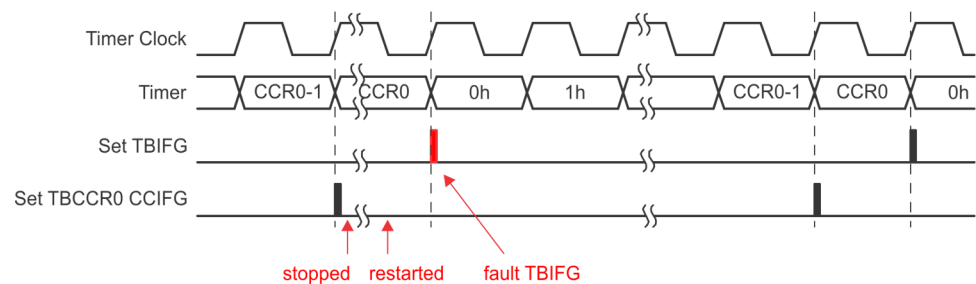
TBIFG Flag is erroneously set after Timer B restarts in Up Mode

In Up Mode, the TBIFG flag should only be set when the timer resets from TBCCR0 to zero. However, if the Timer B is stopped at TBR = TBCCR0, then cleared (TBR=0) by setting the TBCLR bit, and finally restarted in Up Mode, the next rising edge of the TBCLK will erroneously set the TBIFG flag.

None.
