Errata  
**MSP430F47196 Microcontroller**

This document describes the known exceptions to the functional specifications (advisories).

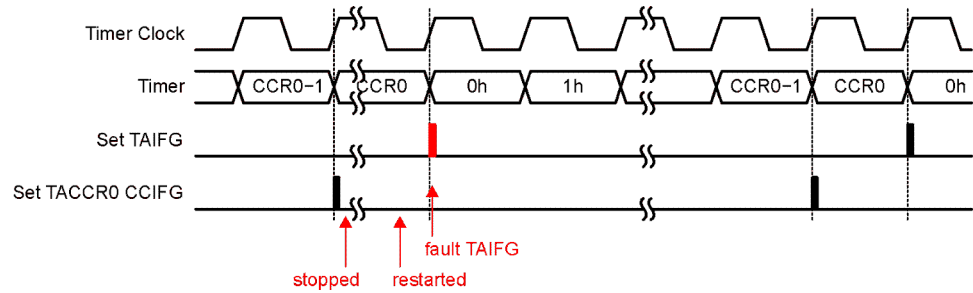
**TA21** *TA Module*

**Function** TAIFG Flag is erroneously set after Timer A restarts in Up Mode

**Description** In Up Mode, the TAIFG flag should only be set when the timer counts from TACCR0 to zero. However, if the Timer A is stopped at TAR = TACCR0, then cleared (TAR=0) by setting the TACLr bit, and finally restarted in Up Mode, the next rising edge of the TACLK will erroneously set the TAIFG flag.

**Workaround** None.

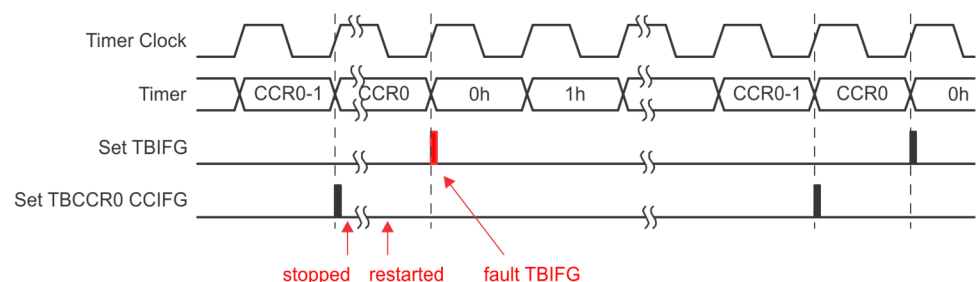
**TB24**

TBIFG Flag is erroneously set after Timer B restarts in Up Mode

In Up Mode, the TBIFG flag should only be set when the timer resets from TBCCR0 to zero. However, if the Timer B is stopped at TBR = TBCCR0, then cleared (TBR=0) by setting the TBCLR bit, and finally restarted in Up Mode, the next rising edge of the TBCLK will erroneously set the TBIFG flag.

None.
