ABSTRACT

This document describes the known exceptions to the functional specifications (advisories).

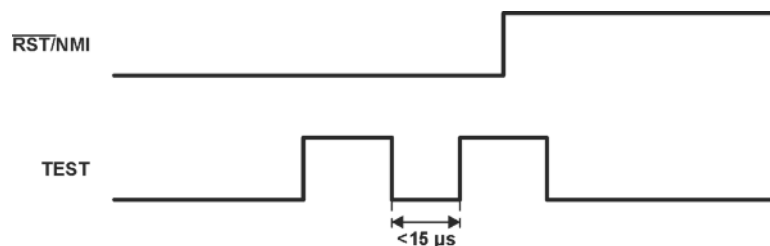
The BSL entry sequence requires that the low phase of the TEST/SBWTCK pin does not exceed 15us. This timing requirement is faster than most PC serial ports can provide, as shown in the following picture. If this requirement is not met, the entry sequence fails and the SYSBSLIND is not set.

Workaround An external hardware solution is recommended to provide the appropriate BSL entry sequence. See [http://processors.wiki.ti.com/index.php/BSL_\(MSP430\)](http://processors.wiki.ti.com/index.php/BSL_(MSP430)) for recommendations on available BSL hardware.
