Errata  
**MSP430F5529 Microcontroller**

This document describes the known exceptions to the functional specifications (advisories).

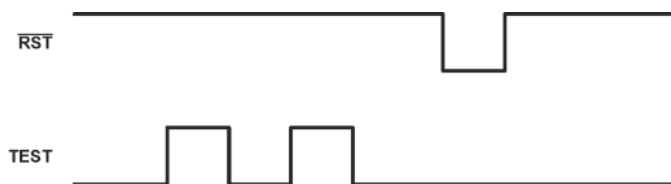
Note: This toggling of TEST pins is not subject to timing constraints. The appropriate level transitions on TEST pin, followed by a RST pulse after 50us, are sufficient to trigger an exit from BSL mode.

- Toggle the TEST pin twice when nRST is high and after 50us pull nRST low.
