ABSTRACT

This document describes the known exceptions to the functional specifications (advisories).

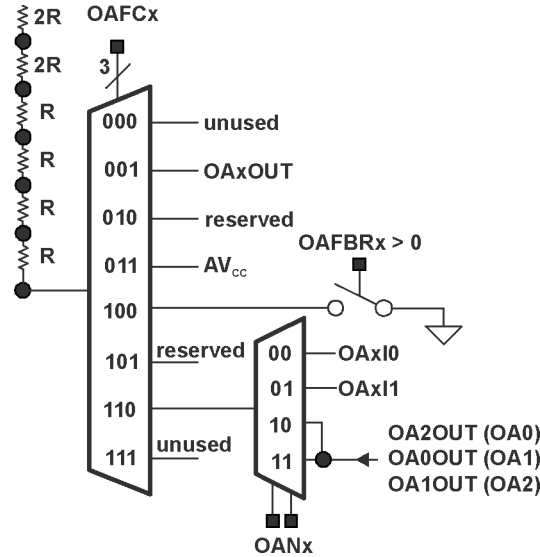
OA1

Function OAxI1 input selection

Description Referring to the OA block diagram in the MSP430x4xx User's Guide, the internal connection of the OAxI1 input to the OAFcX mux is incorrect. The signal input to the OAFcX mux when OANx = 01 is OA0I1 for all OAs. See the figure below for a graphical representation.

Workaround None
