Stellaris® LM3S9B96 RevB1 Errata

This document contains errata as of October 2013 for the Stellaris LM3S9B96 microcontroller. Additional errata added after October 2013 that apply to revision B1 can be found in the *Stellaris® LM3S Tempest- and Firestorm-Class Microcontrollers Errata* ([SPMZ861](#)). Read both documents for the complete list of errata for your device.

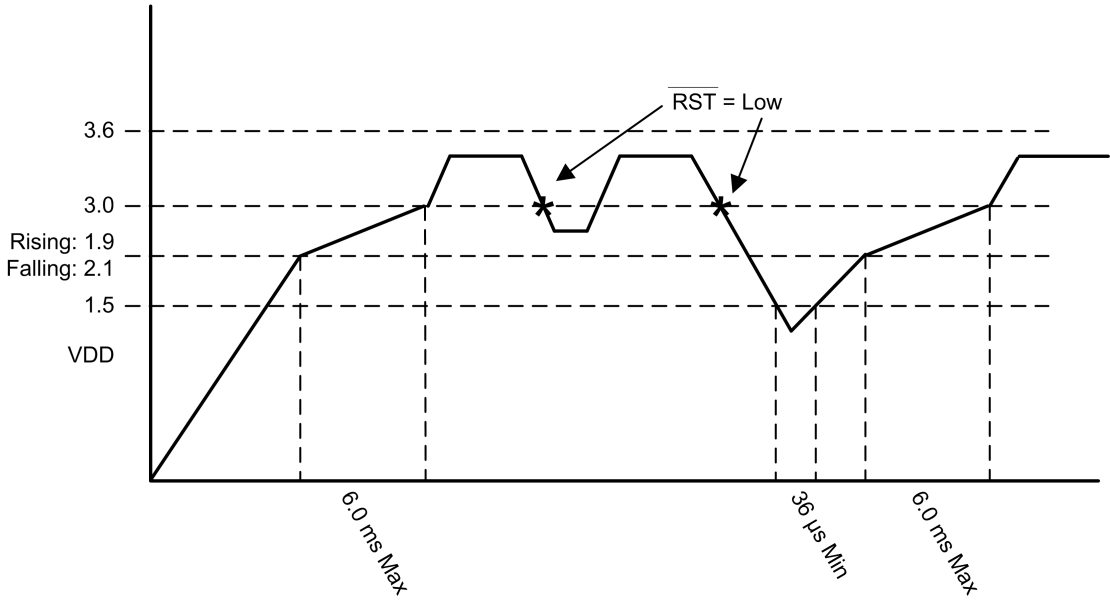
Figure 1. VDD Waveform Signature Limits

Depending on the system environment requirement, items 3, 4, and 5 in the above list may be met by using a voltage supervisor, such as the TLV803M, to monitor a higher voltage rail from which the VDD supply is regulated. Figure 2 on page 14 shows this implementation with a voltage supervisor monitoring the 5-V rail and a voltage trip point of 4.38 V. A voltage supervisor with a lower voltage trip point can be used to monitor the VDD (3.3-V) rail, however this supervisor must assert reset before VDD reaches 3.0 V. Regardless of the implemented voltage supervisor circuit, the system designer must ensure that there is enough time to assert $\overline{\text{RST}}$ Low prior to VDD falling below 3.0 V. Figure 3 on page 15 shows the resulting waveform of the circuit shown in Figure 2 on page 14.

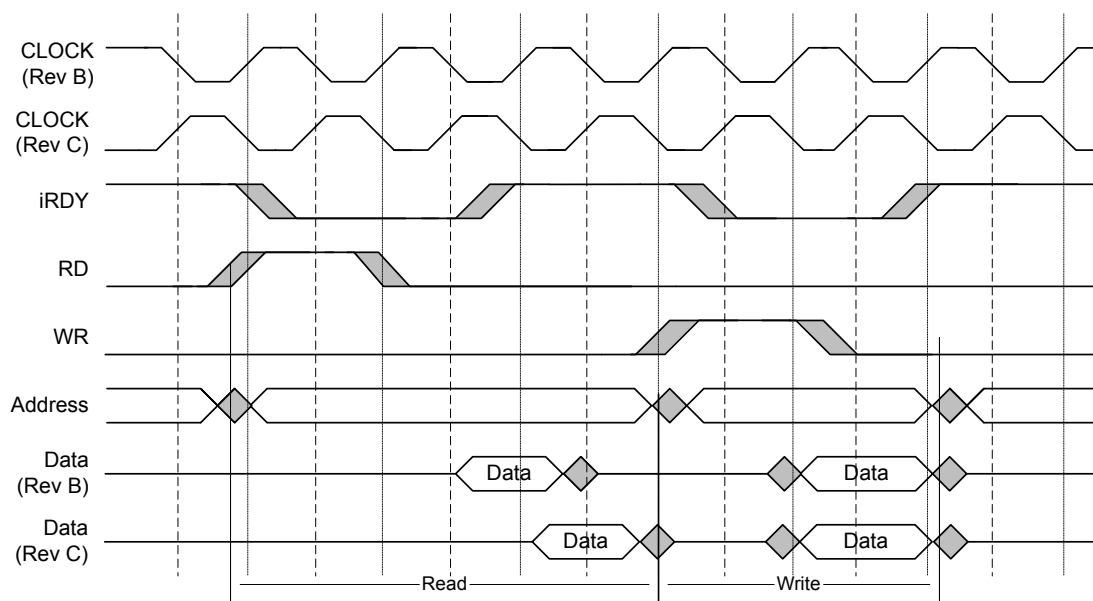
Figure 5. Timing Differences Between Rev B and Rev C Devices

The clock signal that is output on the EPI0S31 signal in General-Purpose mode is inverted. Figure 5 on page 24 shows the timing differences between Rev B parts and Rev C parts.

Use the opposite edge for timing when designing with this interface. During read cycles, ensure that the data meets set up and hold times for the appropriate edge as shown in the diagram above.

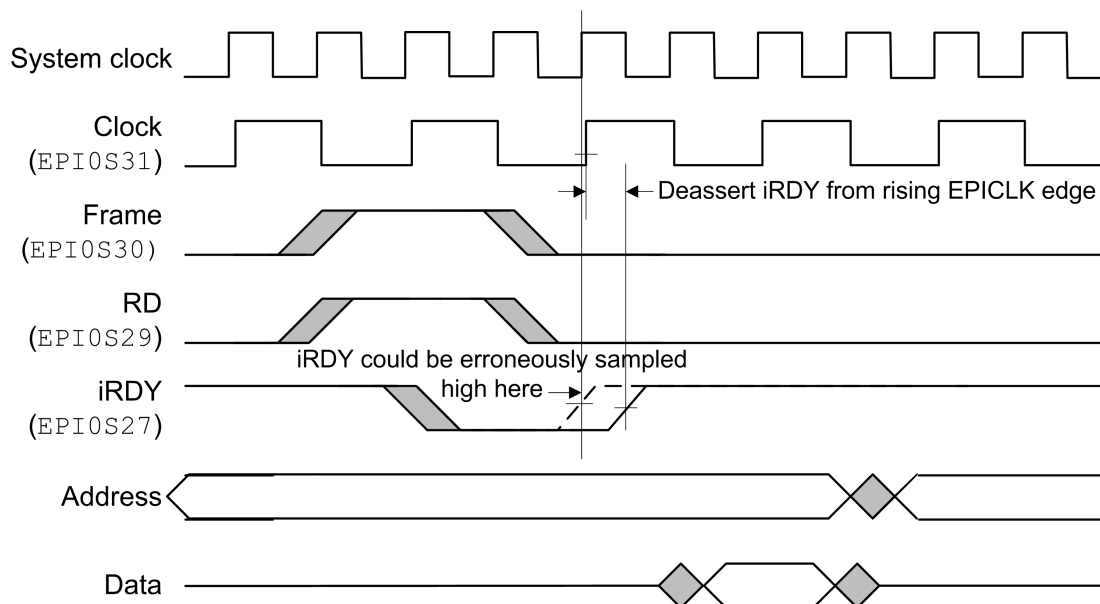
Figure 6. iRDY Timing

For example, if the system clock frequency is configured for 80 MHz (12.5 ns period) and the EPI clock frequency is configured for 40 MHz (25 ns period), there is a 2.5 ns window $((25 \text{ ns} - 12.5 \text{ ns}) - 10 \text{ ns})$, where 10 ns is the iRDY assertion or deassertion set up time (TRDYSU) where the iRDY signal may be asserted. Figure 6 on page 28 shows where iRDY is actually sampled when trying to stall the data phase. iRDY should be deasserted after the next falling edge of EPICLK. iRDY could be erroneously sampled high if it is deasserted at the dotted line.

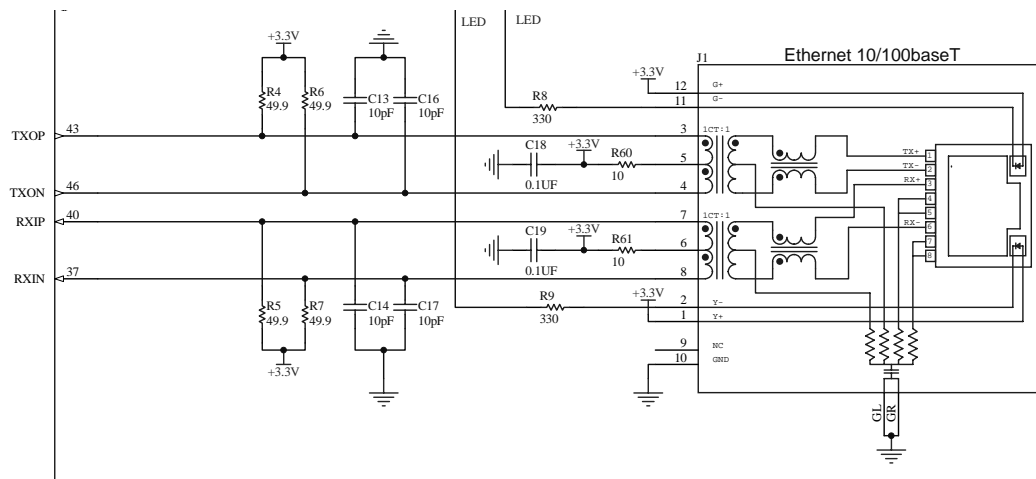
Figure 7. Recommended Center-Tap Connections

The microcontroller experiences some packet loss with Ethernet cables longer than 50 meters in normal operating conditions.

1. Add 10 Ω resistor to the center-tap of the transformer as shown in the figure. These resistors should be replaced by a direct connection for silicon that has this item fixed.
2. Continue using the recommended circuit, but limit cable lengths to 50 meters.

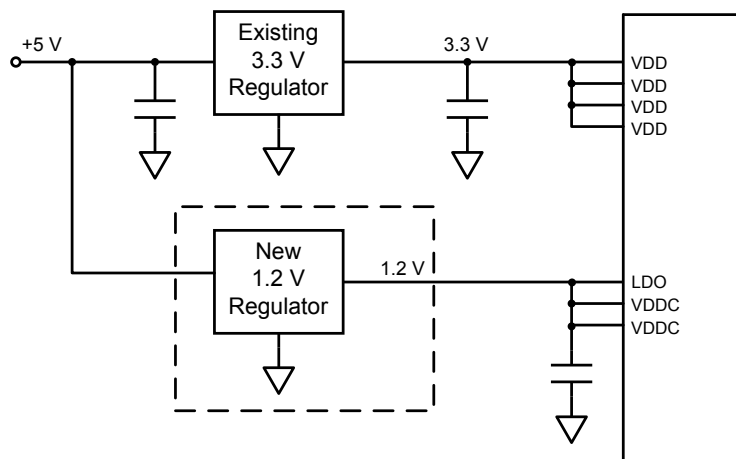
Figure 13. Configuration of External Regulator

Incorrect power sequencing during power up can disrupt operation and potentially cause device failure.

V_{DDC} must be applied approximately 50 μs before V_{DD} . Normally V_{DDC} is controlled by the part's internal LDO voltage regulator. The workaround requires the addition of an external regulator (see Figure 13) to ensure that V_{DDC} sequencing requirements are met (see Figure 14). A recommended regulator is the TI TPS73101DBVR.

This fix mitigates the on-chip power issue, but does not solve it completely. During development, the Flash memory should also be reprogrammed (using LMFlash or another programming tool) at least once a week.
