## Stellaris<sup>®</sup> LM3S6G65 RevA2 Errata

This document contains known errata at the time of publication for the Stellaris LM3S6G65 microcontroller. The table below summarizes the errata and lists the affected revisions. See the data sheet for more details.

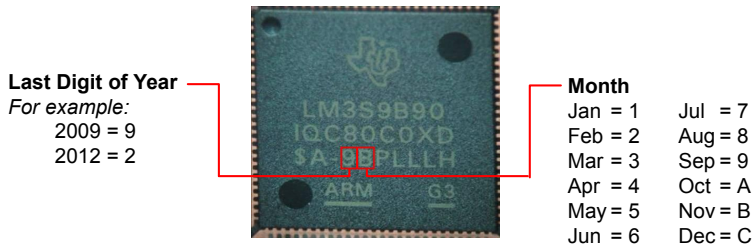
**Note:** To determine the date code of your part, look at the first two characters following the dash on the third line of the part markings (highlighted in red in the following figure). The first number after the dash indicates the last decimal digit of the year. The second character indicates the month. Therefore, the following example shows a date code of 9B which indicates November 2009.
