Stellaris[®] LM3S6C65 RevA2 Errata

This document contains known errata at the time of publication for the Stellaris LM3S6C65 microcontroller. The table below summarizes the errata and lists the affected revisions. See the data sheet for more details.

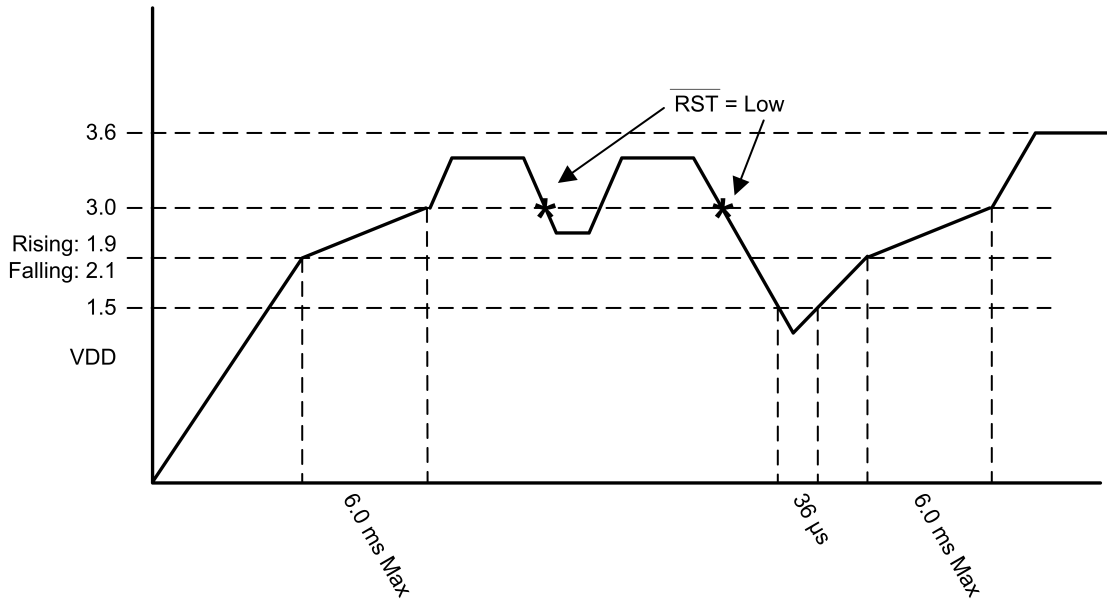
Figure 1. VDD Waveform Signature Limits

The Power-On Reset gap occurs because the supervisor can release internal state machine operation as soon as 6.0 ms after the VDD supply reaches 1.9 V. If VDD is still below the minimum operating voltage of 3.0 V after 6.0 ms, the power-up state machine may not function correctly, resulting in the effects described above. The $\overline{\text{RST}}$ pin of the device has no effect on the initialization state machine, therefore, a complete power-cycle is required to restore the initialization state machine.

The Brown-Out Reset threshold (V_{BTH}) gap occurs because the brown-out supervisor has a threshold as low as 2.85 V, which is less than the minimum operating voltage on VDD, and also because it can take several microseconds to respond. BOR gaps can be encountered after power up, during steady state operation power-on, if the VDD rail has glitches, and also during power-down.

After initial power-up, any processor operation with VDD below 3.0 V may result in unexpected code execution resulting in the effects described above. The processor must be halted or the \overline{RST} signal must be driven Low prior to VDD dropping below 3.0 V and stay in that state until VDD is above 3.0 V.

If VDD falls below 2.1 V, it must continue to fall until it reaches 1.5 V. VDD must stay below 1.5 V for at least 36 μ s to ensure that a POR is triggered correctly. Additionally, the VDD power-up time between 1.9 V and 3.0 V must be at most 6.0 ms. If VDD falls below 3.0 V but stays above 2.1 V, it is not necessary for the voltage to continue falling below 2.1 V. VDD can come back up to 3.0 V without any additional timing requirements.

1. The VDD power-up, steady state, and power-down waveform meets the timing requirements shown in Figure 1 on page 12.
2. The power-up transition of VDD between 1.9 V and 3.0 V must not have any points where it decreases in voltage (must be monotonic).
3. The power-down transition of VDD between 3.0 V and 1.5 V must not have any points where it increases in voltage (must be monotonic).
4. Once steady-state operation between 3.0 V and 3.6 V is achieved, \overline{RST} must go Low or the CPU execution must be halted prior to VDD falling below 3.0 V.
5. The **Brown-Out Reset Control (PBORCTL)** register must be set so that a brown-out event causes a reset.
