Stellaris[®] LM3S8G62 RevA2 Errata

This document contains known errata at the time of publication for the Stellaris LM3S8G62 microcontroller. The table below summarizes the errata and lists the affected revisions. See the data sheet for more details.

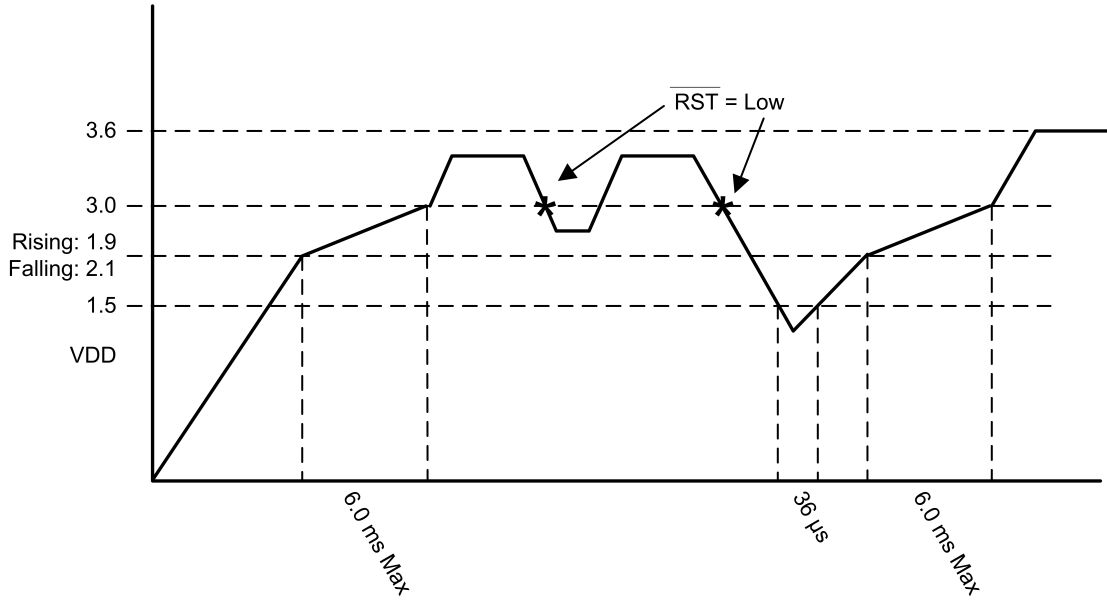
Figure 1. VDD Waveform Signature Limits

The Power-On Reset gap occurs because the supervisor can release internal state machine operation as soon as 6.0 ms after the VDD supply reaches 1.9 V. If VDD is still below the minimum operating voltage of 3.0 V after 6.0 ms, the power-up state machine may not function correctly, resulting in the effects described above. The $\overline{\text{RST}}$ pin of the device has no effect on the initialization state machine, therefore, a complete power-cycle is required to restore the initialization state machine.

The Brown-Out Reset threshold (V_{BTH}) gap occurs because the brown-out supervisor has a threshold as low as 2.85 V, which is less than the minimum operating voltage on VDD, and also because it can take several microseconds to respond. BOR gaps can be encountered after power up, during steady state operation power-on, if the VDD rail has glitches, and also during power-down.

After initial power-up, any processor operation with VDD below 3.0 V may result in unexpected code execution resulting in the effects described above. The processor must be halted or the \overline{RST} signal must be driven Low prior to VDD dropping below 3.0 V and stay in that state until VDD is above 3.0 V.

If VDD falls below 2.1 V, it must continue to fall until it reaches 1.5 V. VDD must stay below 1.5 V for at least 36 μ s to ensure that a POR is triggered correctly. Additionally, the VDD power-up time between 1.9 V and 3.0 V must be at most 6.0 ms. If VDD falls below 3.0 V but stays above 2.1 V, it is not necessary for the voltage to continue falling below 2.1 V. VDD can come back up to 3.0 V without any additional timing requirements.

1. The VDD power-up, steady state, and power-down waveform meets the timing requirements shown in Figure 1 on page 12.
2. The power-up transition of VDD between 1.9 V and 3.0 V must not have any points where it decreases in voltage (must be monotonic).
3. The power-down transition of VDD between 3.0 V and 1.5 V must not have any points where it increases in voltage (must be monotonic).
4. Once steady-state operation between 3.0 V and 3.6 V is achieved, \overline{RST} must go Low or the CPU execution must be halted prior to VDD falling below 3.0 V.
5. The **Brown-Out Reset Control (PBORCTL)** register must be set so that a brown-out event causes a reset.
