## Stellaris® LM4F211H5QR Rev A1/A3/B0 Errata

**Note:** The Stellaris LM4F211H5QR microcontroller has been replaced by the identical Tiva™ C Series TM4C123AH6PM microcontroller.

This document contains known errata at the time of publication for the Stellaris LM4F211H5QR microcontroller, revisions A1, A3, and B0. Additional errata that applies to revisions A1, A3, and B0, as well as revisions following B0 can be found in *Stellaris® LM4F Microcontrollers Silicon Revisions 6 and 7 Errata (SPMZ856)*. Read both documents for a complete list of errata for your device.

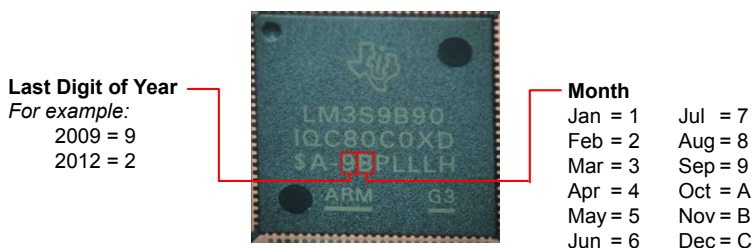
**Note:** To determine the date code of your part, look at the first two characters following the dash on the third line of the part markings (highlighted in red in the following figure). The first number after the dash indicates the last decimal digit of the year. The second character indicates the month. Therefore, the following example shows a date code of 9B which indicates November 2009.
