Errata  
**MSP430F47197 Microcontroller**

This document describes the known exceptions to the functional specifications (advisories).

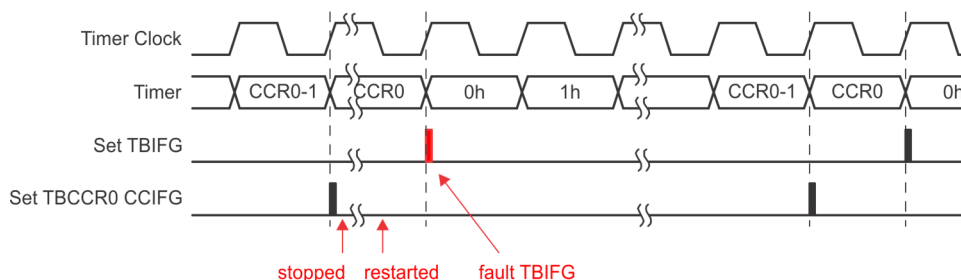
**TB24**

TBIFG Flag is erroneously set after Timer B restarts in Up Mode

In Up Mode, the TBIFG flag should only be set when the timer resets from TBCCR0 to zero. However, if the Timer B is stopped at TBR = TBCCR0, then cleared (TBR=0) by setting the TBCLR bit, and finally restarted in Up Mode, the next rising edge of the TBCLK will erroneously set the TBIFG flag.

None.
