F28E12x Real-Time MCUs Silicon Errata

Silicon Revision 0

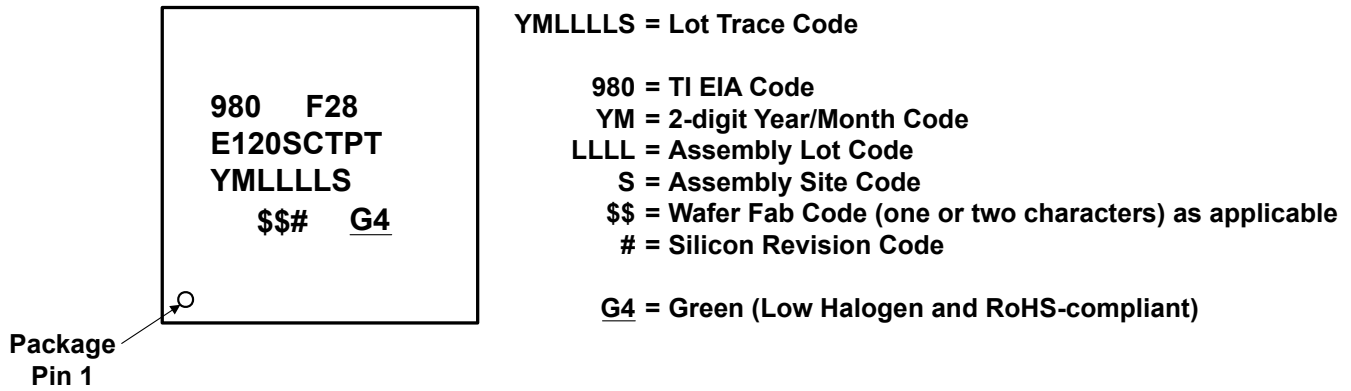
Figure 2-1. Package Symbolization for PT Package

F28E120SCTPT units with YM = '5A' were incorrectly printed with Silicon Revision Code = 'A'. These units are silicon revision 0 (# is blank).

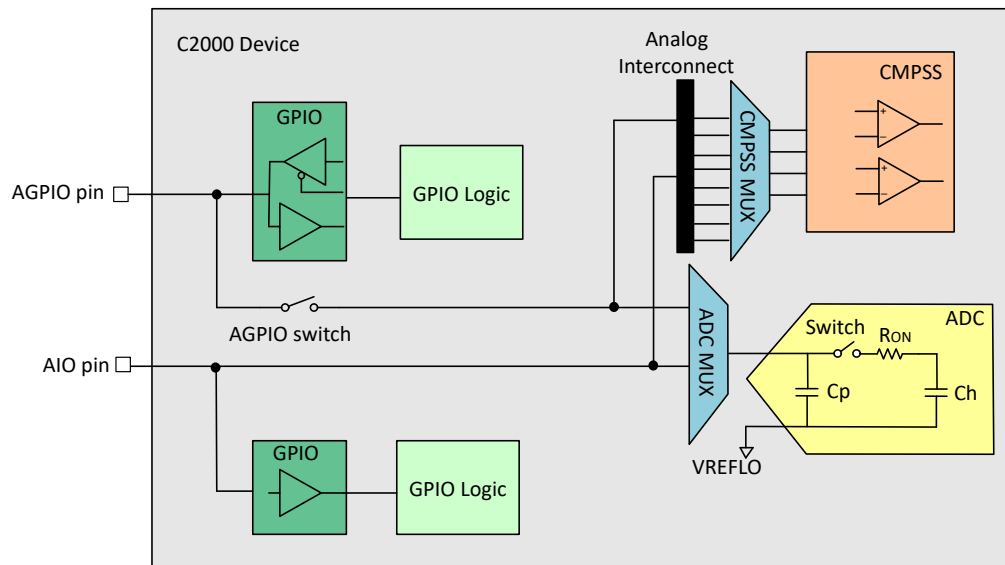
Figure 3-1. Analog Subsystem Diagram with AGPIO and AIO Analog Pin Types
Workarounds

The AGPIO analog pin path contains an extra series switch of 53Ω. This creates a low-capacitance isolated node shared by the ADC and CMPSS comparator, as shown in [Figure 3-1](#). This node can be disturbed when the ADC samples the channel (depending on the prior voltage stored on the ADC sample-and-hold capacitor), and this disturbance can cause a false CMPSS event of up to 50ns. To accommodate this potential disturbance, the workarounds below can be implemented.

1. Use a different pin (that is AIO pin type) for analog channels that need both ADC and CMPSS together.
2. Use the CMPSS Digital Filter with a setting of 50ns or greater, which will filter the temporary disturbance.
3. Pre-condition the sample-and-hold capacitor of the ADC so that the disturbance will not cause a false trip. For example, perform a dummy read of a 3.3V connection from a different channel on the ADC immediately before the impacted channel is read,

so the disturbance is in the positive direction, away from the false trip. The opposite dummy read of a 0V signal would be used if the false trip is inverted in polarity.
