MSP430BT5190 Device Erratasheet

The revision of the device can be identified by the revision letter on the [Package Markings](#) or by the [HW_ID](#) located inside the TLV structure of the device

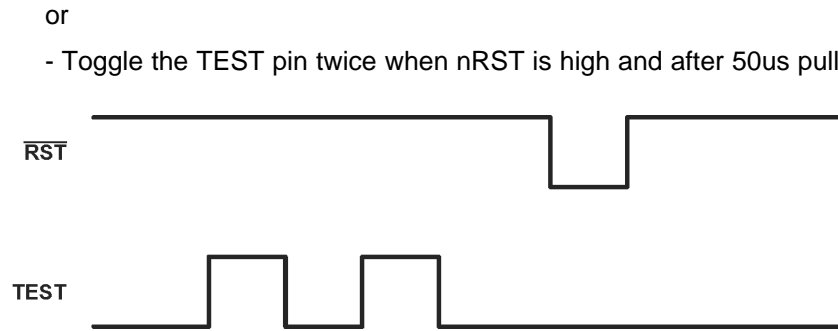
To exit the BSL one of the following methods must be used.

- A Power cycle

Note: This toggling of TEST pins is not subject to timing constraints. The appropriate level transitions on TEST pin, followed by a RST pulse after 50us, are sufficient to trigger an exit from BSL mode.
