CC430F5133 Device Erratasheet

The revision of the device can be identified by the revision letter on the [Package Markings](#) or by the [HW_ID](#) located inside the TLV structure of the device

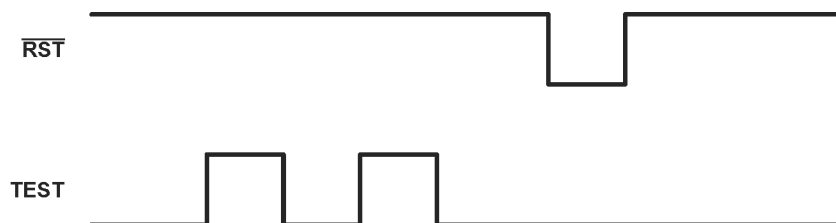
To exit the BSL one of the following methods must be used.

- A Power cycle
- or
- Toggle the TEST pin twice when nRST is high and after 50us pull nRST low.

Note: This toggling of TEST pins is not subject to timing constraints. The appropriate level transitions on TEST pin, followed by a RST pulse after 50us, are sufficient to trigger an exit from BSL mode.
