CC430F6125 Device Erratasheet

1 Functional Errata Revision History

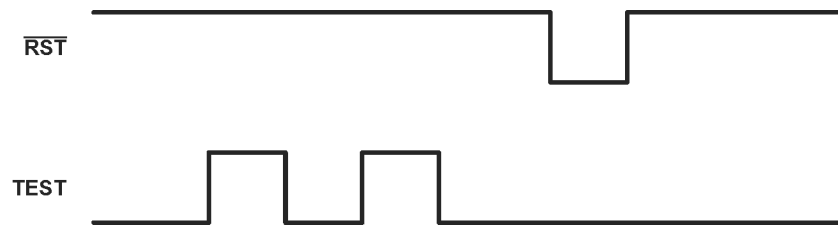
Category	Software in ROM
Function	BSL does not exit to application code
Description	The methods used to exit the BSL per MSP430 Programming Via the Bootstrap Loader (SLAU319) are invalid.
Workaround	To exit the BSL one of the following methods must be used. - A Power cycle or - Toggle the TEST pin twice when nRST is high and after 50us pull nRST low.

Note: This toggling of TEST pins is not subject to timing constraints. The appropriate level transitions on TEST pin, followed by a RST pulse after 50us, are sufficient to trigger an exit from BSL mode.
