MSP430AFE251 Device Erratasheet

1 Functional Errata Revision History

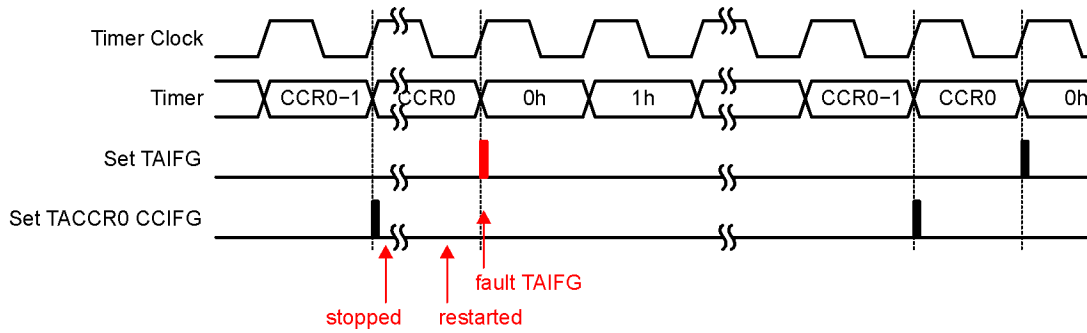
TA21 ***TIMER_A Module***

| Function | TAIFG Flag is erroneously set after Timer A restarts in Up Mode |
| Description | In Up Mode, the TAIFG flag should only be set when the timer counts from TACCR0 to zero. However, if the Timer A is stopped at TAR = TACCR0, then cleared (TAR=0) by setting the TACLR bit, and finally restarted in Up Mode, the next rising edge of the TACLK will erroneously set the TAIFG flag. |

Workaround None.
