MSP430F1122 Device Erratasheet

1 Functional Errata Revision History

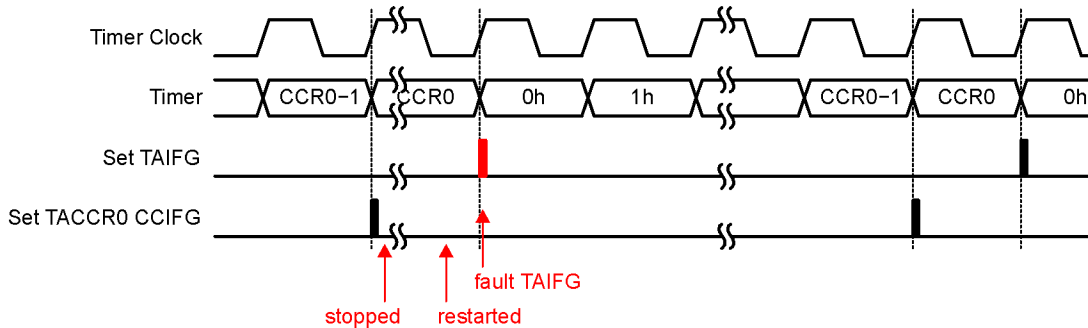
TA21 *TIMER_A Module*

Function TAIFG Flag is erroneously set after Timer A restarts in Up Mode

Description In Up Mode, the TAIFG flag should only be set when the timer counts from TACCR0 to zero. However, if the Timer A is stopped at TAR = TACCR0, then cleared (TAR=0) by setting the TACLR bit, and finally restarted in Up Mode, the next rising edge of the TACLK will erroneously set the TAIFG flag.

Workaround None.
