MSP430F1132 Device Erratasheet

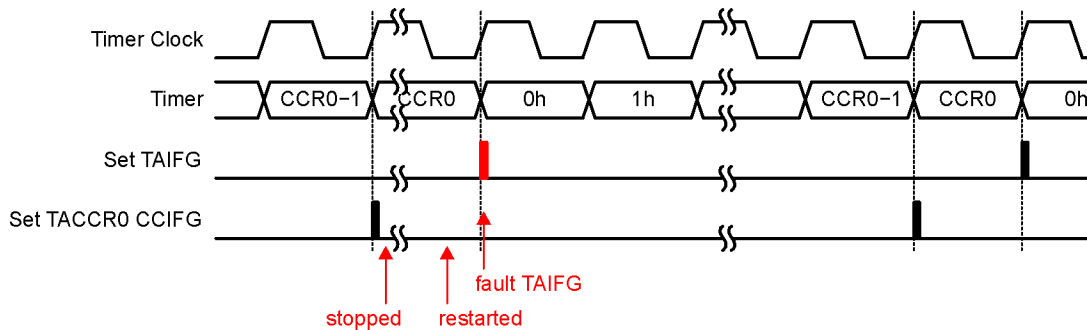
TA21 *TIMER_A Module*

Function TAIFG Flag is erroneously set after Timer A restarts in Up Mode

Description In Up Mode, the TAIFG flag should only be set when the timer counts from TACCR0 to zero. However, if the Timer A is stopped at TAR = TACCR0, then cleared (TAR=0) by setting the TACLR bit, and finally restarted in Up Mode, the next rising edge of the TACLK will erroneously set the TAIFG flag.

Workaround None.
