MSP430F1222 Device Erratasheet

1 Functional Errata Revision History

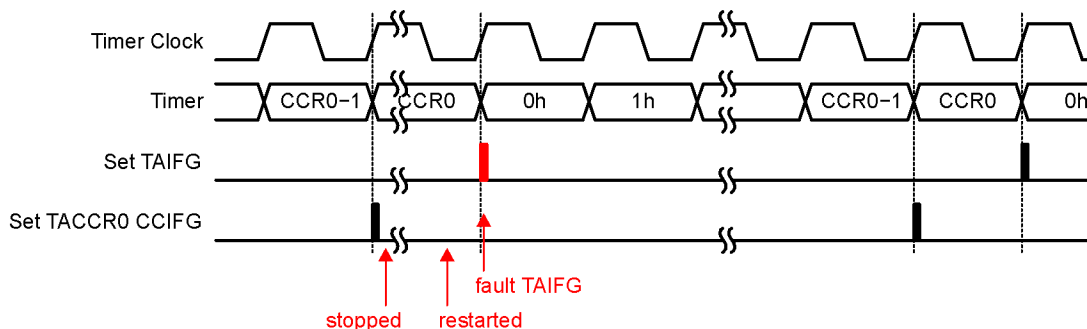
TA21 *TIMER_A Module*

Function TAIFG Flag is erroneously set after Timer A restarts in Up Mode

Description In Up Mode, the TAIFG flag should only be set when the timer counts from TACCR0 to zero. However, if the Timer A is stopped at TAR = TACCR0, then cleared (TAR=0) by setting the TACLR bit, and finally restarted in Up Mode, the next rising edge of the TACLK will erroneously set the TAIFG flag.

Workaround None.
