# MSP430F123 Device Erratasheet

## 1 Functional Errata Revision History

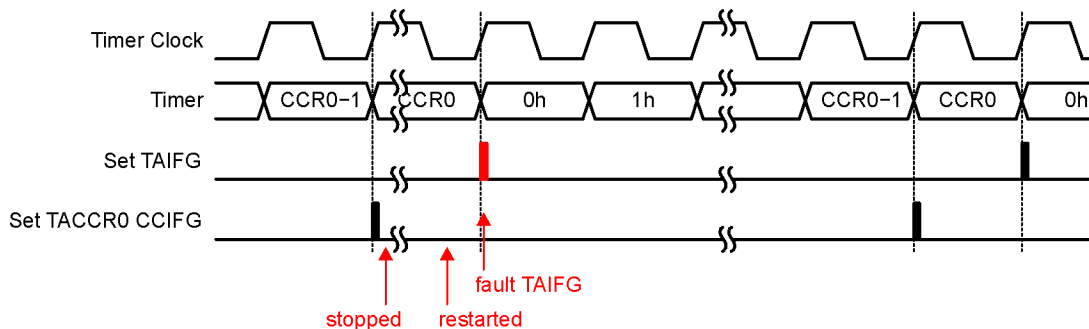
<b>TA21</b>	<b>TIMER_A Module</b>
<b>Category</b>	Functional
<b>Function</b>	TAIFG Flag is erroneously set after Timer A restarts in Up Mode
<b>Description</b>	In Up Mode, the TAIFG flag should only be set when the timer counts from TACCR0 to zero. However, if the Timer A is stopped at TAR = TACCR0, then cleared (TAR=0) by setting the TACL bit, and finally restarted in Up Mode, the next rising edge of the TACLK will erroneously set the TAIFG flag.

<b>Workaround</b>	None.
-------------------	-------
