# MSP430F133 Device Erratasheet

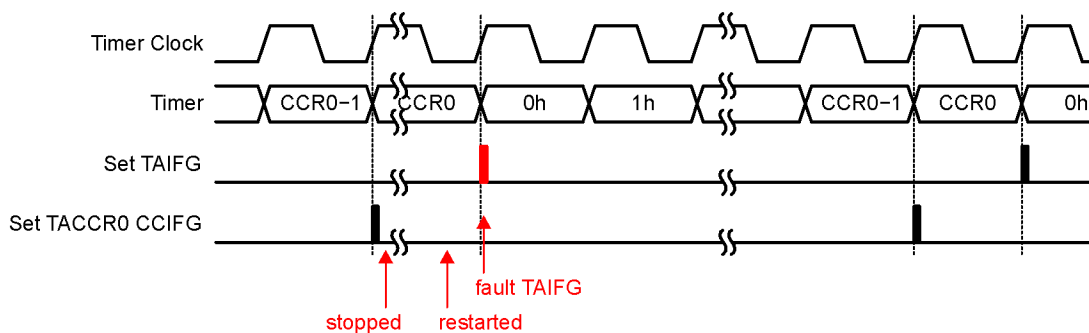
**TA21** *TIMER\_A Module*

**Function** TAIFG Flag is erroneously set after Timer A restarts in Up Mode

**Description** In Up Mode, the TAIFG flag should only be set when the timer counts from TACCR0 to zero. However, if the Timer A is stopped at  $TAR = TACCR0$ , then cleared ( $TAR=0$ ) by setting the TACLR bit, and finally restarted in Up Mode, the next rising edge of the TACLK will erroneously set the TAIFG flag.

**Workaround** None.

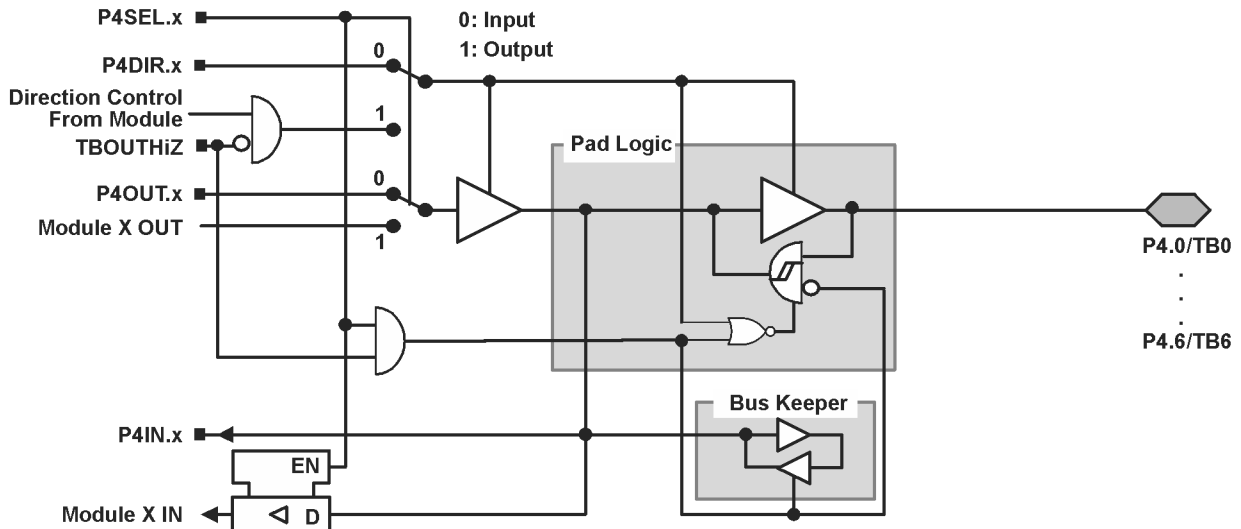
Port function as specified

**port P4, P4.0 to P4.6, input/output with Schmitt-trigger**

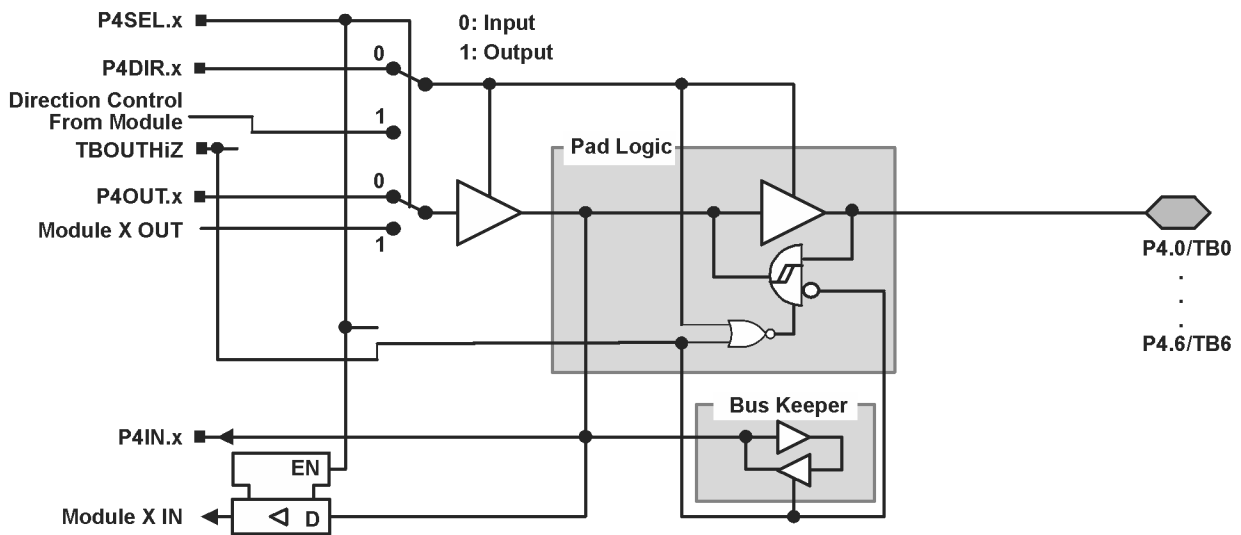
**Port Realization With TB3 Bug**

<b>Workaround</b>	Switch capture/compare mode to capture mode before the CCRx register increment. Switch back to compare mode afterward.
<hr/>	
<b>TB3</b>	<b><i>TIMER_B Module</i></b>
<b>Category</b>	Functional
<b>Function</b>	Port is switched to 3-state independent of selected function
<b>Description</b>	<p>Incorrect 3-state function of Ports P4.0/TB0 through P4.6/TB6 (TBoutHiZ control). If TBoutHiZ is set to high, all ports P4.0/TB0 through P4.6/TB6 are set to 3-state, independent of the P4SEL.x control signals. This means a port P4.x is switched to 3-state with TBoutHiZ, even if it is not selected for Timer_B function. In addition, the ports P4.0/TB0 through P4.6/TB6 are switched to 3-state with TBoutHiZ, even if the port direction (direction control from module) is set to input. This is in accordance with the specification description but, nevertheless, is an unexpected behavior.</p>

**Workaround** No workaround.
