# MSP430F135 Device Erratasheet

## 1 Functional Errata Revision History

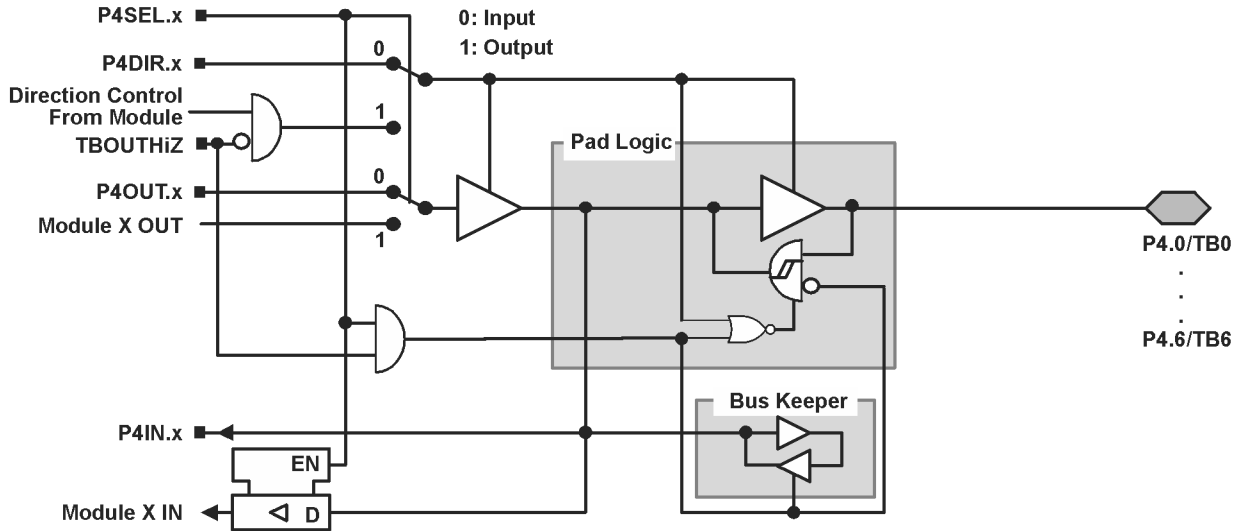
**port P4, P4.0 to P4.6, input/output with Schmitt-trigger**

Port function as specified

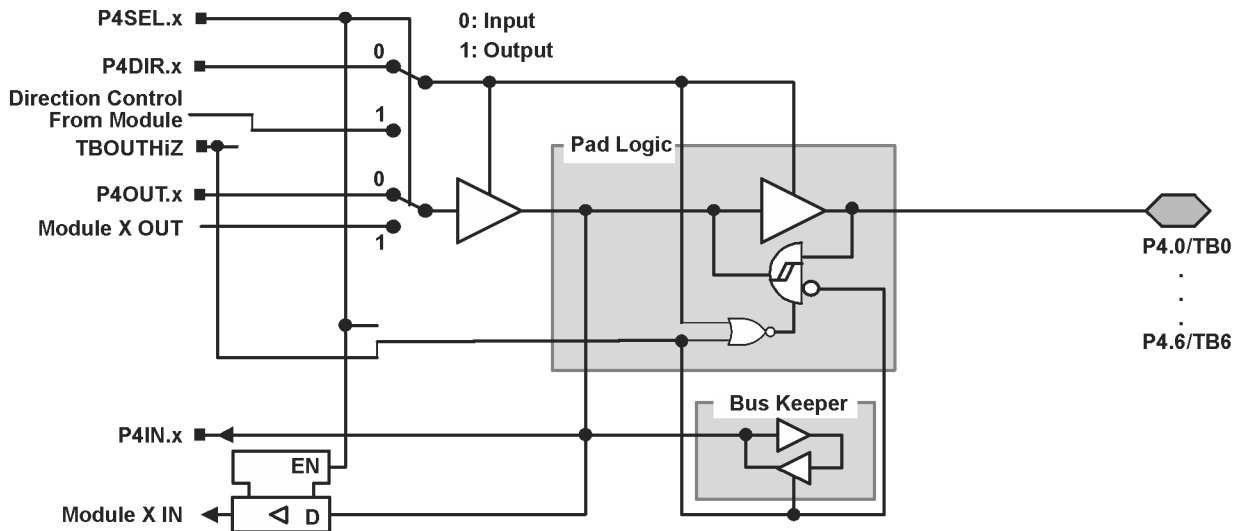
**port P4, P4.0 to P4.6, input/output with Schmitt-trigger**

<b>Workaround</b>	Switch capture/compare mode to capture mode before the CCRx register increment. Switch back to compare mode afterward.
<hr/>	
<b>TB3</b>	<b><i>TIMER_B Module</i></b>
<b>Category</b>	Functional
<b>Function</b>	Port is switched to 3-state independent of selected function
<b>Description</b>	<p>Incorrect 3-state function of Ports P4.0/TB0 through P4.6/TB6 (TBoutHiZ control). If TBoutHiZ is set to high, all ports P4.0/TB0 through P4.6/TB6 are set to 3-state, independent of the P4SEL.x control signals. This means a port P4.x is switched to 3-state with TBoutHiZ, even if it is not selected for Timer_B function. In addition, the ports P4.0/TB0 through P4.6/TB6 are switched to 3-state with TBoutHiZ, even if the port direction (direction control from module) is set to input. This is in accordance with the specification description but, nevertheless, is an unexpected behavior.</p>

**Port Realization With TB3 Bug**

**Workaround** No workaround.

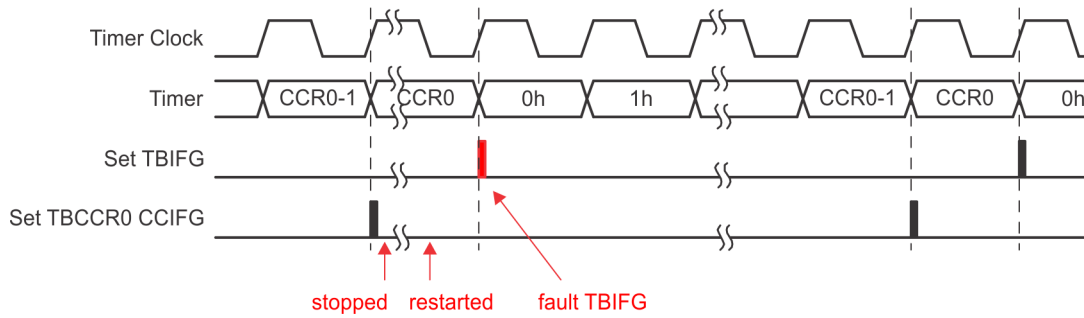
**TB24** ***TIMER\_B Module***

<b>Category</b>	Functional
<b>Function</b>	TBIFG Flag is erroneously set after Timer B restarts in Up Mode
<b>Description</b>	In Up Mode, the TBIFG flag should only be set when the timer resets from TBCCR0 to zero. However, if the Timer B is stopped at TBR = TBCCR0, then cleared (TBR=0) by setting the TBCLR bit, and finally restarted in Up Mode, the next rising edge of the TBCLK will erroneously set the TBIFG flag.

**Workaround** None.
