MSP430F147 Device Erratasheet

1 Functional Errata Revision History

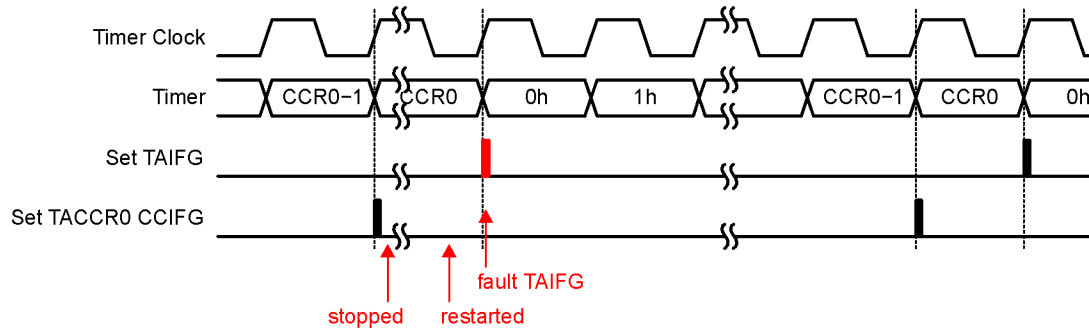
TA21 ***TIMER_A Module***

Category	Functional
Function	TAIFG Flag is erroneously set after Timer A restarts in Up Mode
Description	<p>In Up Mode, the TAIFG flag should only be set when the timer counts from TACCR0 to zero. However, if the Timer A is stopped at TAR = TACCR0, then cleared (TAR=0) by setting the TACLR bit, and finally restarted in Up Mode, the next rising edge of the</p>

TACLK will erroneously set the TAIFG flag.

Workaround None.

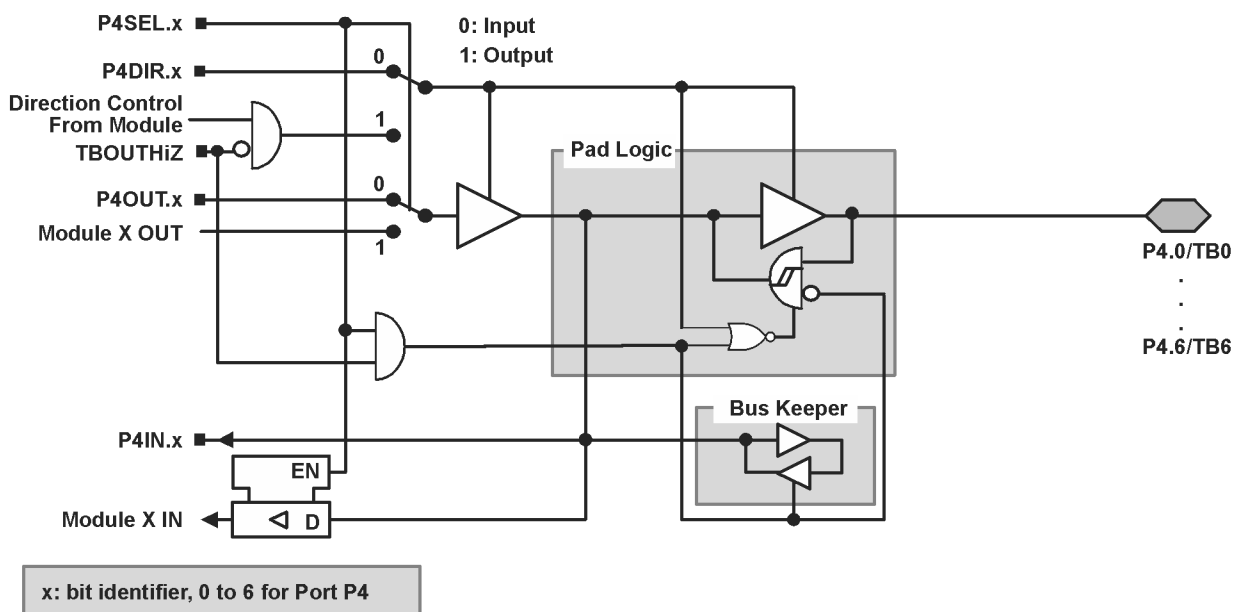
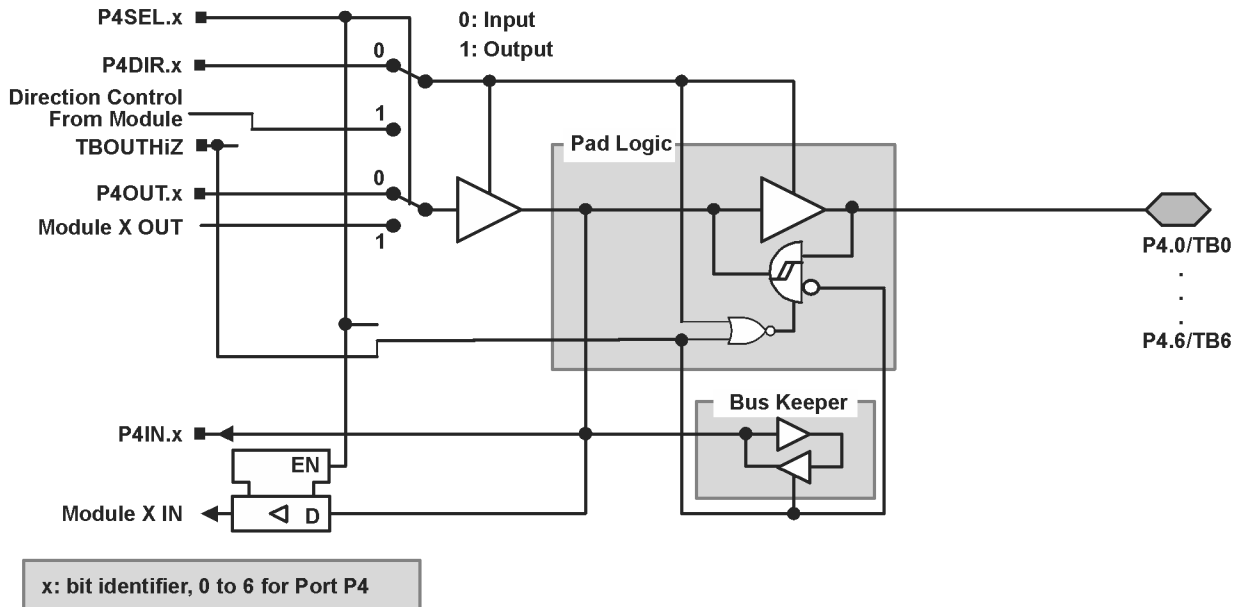
Port Realization With TB3 Bug

Function Port is switched to 3-state independent of selected function

Description Incorrect 3-state function of Ports P4.0/TB0 through P4.6/TB6 (TBoutHiZ control). If TBoutHiZ is set to high, all ports P4.0/TB0 through P4.6/TB6 are set to 3-state, independent of the P4SEL.x control signals. This means a port P4.x is switched to 3-state with TBoutHiZ, even if it is not selected for Timer_B function. In addition, the ports P4.0/TB0 through P4.6/TB6 are switched to 3-state with TBoutHiZ, even if the port direction (direction control from module) is set to input. This is in accordance with the specification description but, nevertheless, is an unexpected behavior.

Workaround No workaround.
Port function as specified

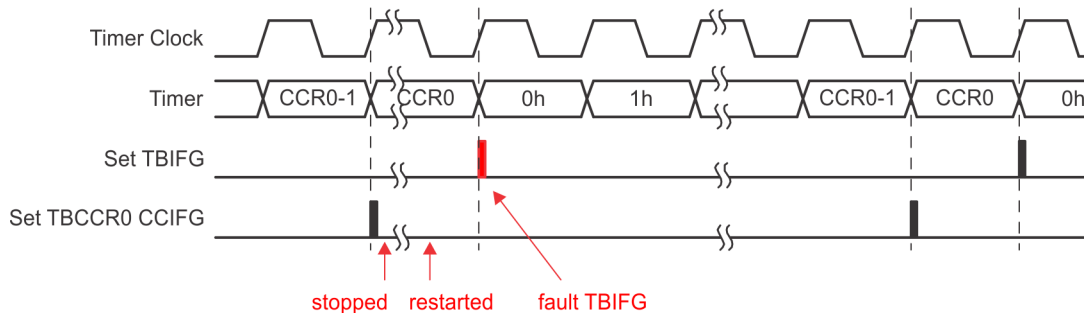
TB24 *TIMER_B Module*

Function TBIFG Flag is erroneously set after Timer B restarts in Up Mode

Description In Up Mode, the TBIFG flag should only be set when the timer resets from TBCCR0 to zero. However, if the Timer B is stopped at TBR = TBCCR0, then cleared (TBR=0) by setting the TBCLR bit, and finally restarted in Up Mode, the next rising edge of the TBCLK will erroneously set the TBIFG flag.

Workaround None.
