# MSP430F148 Device Erratasheet

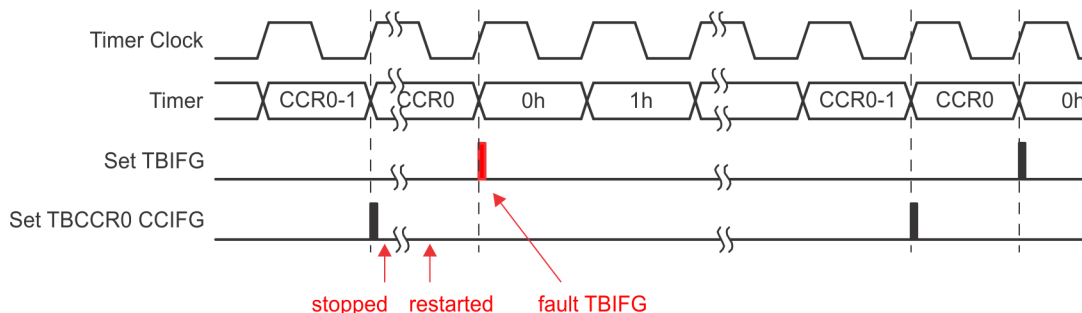
**TB24** *TIMER\_B Module*

**Function** TBIFG Flag is erroneously set after Timer B restarts in Up Mode

**Description** In Up Mode, the TBIFG flag should only be set when the timer resets from TBCCR0 to zero. However, if the Timer B is stopped at TBR = TBCCR0, then cleared (TBR=0) by setting the TBCLR bit, and finally restarted in Up Mode, the next rising edge of the TBCLK will erroneously set the TBIFG flag.

**Workaround** None.
