MSP430F2002 Device Erratasheet

1 Functional Errata Revision History

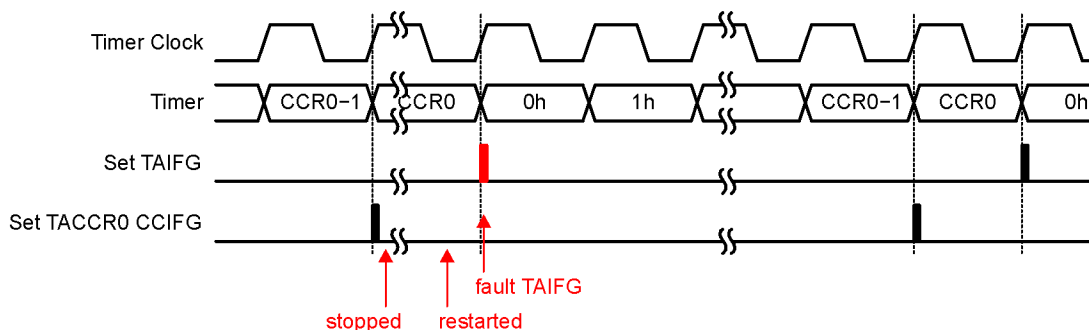
TA21 *TIMER_A Module*

Function TAIFG Flag is erroneously set after Timer A restarts in Up Mode

Description In Up Mode, the TAIFG flag should only be set when the timer counts from TACCR0 to zero. However, if the Timer A is stopped at TAR = TACCR0, then cleared (TAR=0) by setting the TACLK bit, and finally restarted in Up Mode, the next rising edge of the TACLK will erroneously set the TAIFG flag.

Workaround None.
