# MSP430F2013 Device Erratasheet

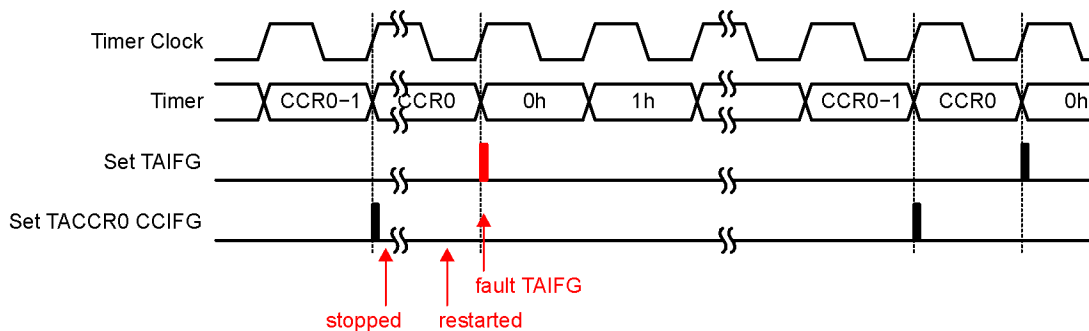
**TA21** *TIMER\_A Module*

**Function** TAIFG Flag is erroneously set after Timer A restarts in Up Mode

**Description** In Up Mode, the TAIFG flag should only be set when the timer counts from TACCR0 to zero. However, if the Timer A is stopped at TAR = TACCR0, then cleared (TAR=0) by setting the TACLRL bit, and finally restarted in Up Mode, the next rising edge of the TACLK will erroneously set the TAIFG flag.

**Workaround** None.
